**Project full title:** Energy flexible DYnamic building CErtification

Deliverable number:	<b>D5.2</b>
Deliverable title:	<b>Geneva case study report #1 and #5 Geneva</b>
Work package:	WP5
Due date of deliverable:	M24
Actual submission date:	M25 - 01/09/2022
Start date of project:	01/09/2020
Duration:	36 months
Reviewer(s):	Daniel Leiria (AAU)
Author/editor:	Laurent Tippenhauer (OCEN)
Contributing partners:	ESTIA

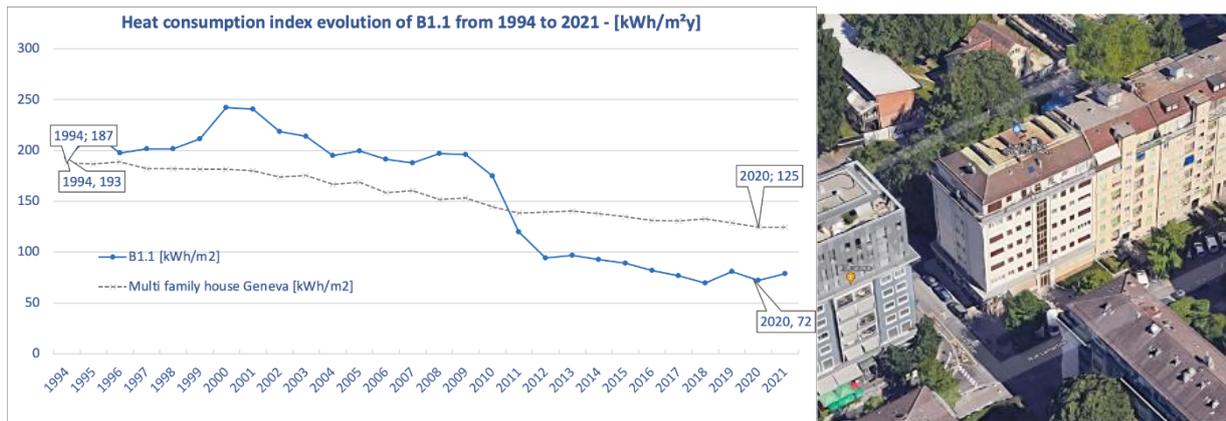
**Figure 1: Annual final heat consumption evolution of B1.1**

This building was refurbished in 2011, presenting a very high energy performance gap after commissioning (200%). After several years of optimization, it significantly reduced its energy consumption, but it still consumes 30% more energy than expected. The evolution of the building energy consumption since 1994 is shown in Figure 1, compared to all the canton building stock evolution, using the cantonal GIS energy consumption database. Refurbishment happened in 2011, and optimization took place from 2012 to 2016. The possible technical optimization actions have been almost all tested.

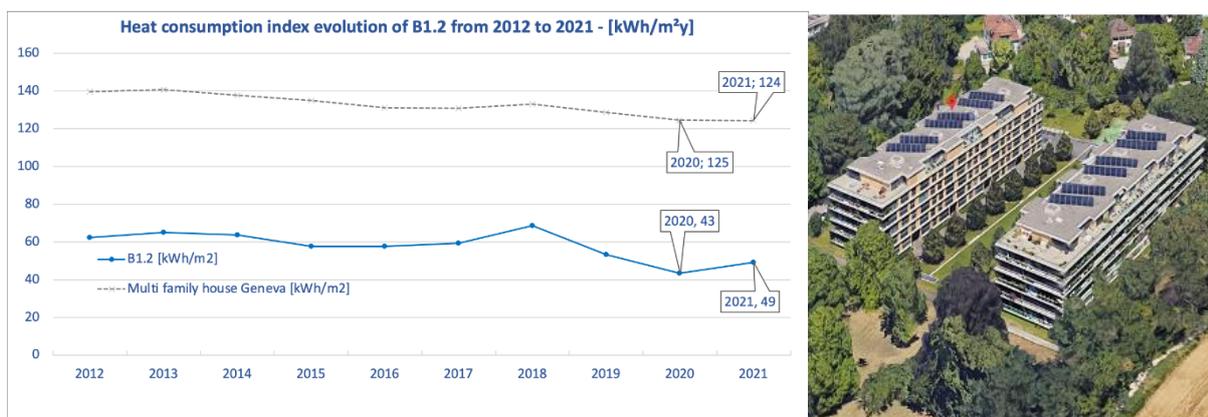
**Figure 2: Annual final heat consumption evolution of B1.2**

Building B1.2 is a new NZEB building recently commissioned but not optimized, and its energy consumption does not meet the high energy performance building expectations. Since its commissioning, there have been efforts to reduce the building's energy consumption to meet the anticipated value. A few installation errors were found in the technical systems that could explain part of it. Since 2018, an optimization system has been installed on the heater, which seems to improve the overall energy consumption, as presented in Figure 2.

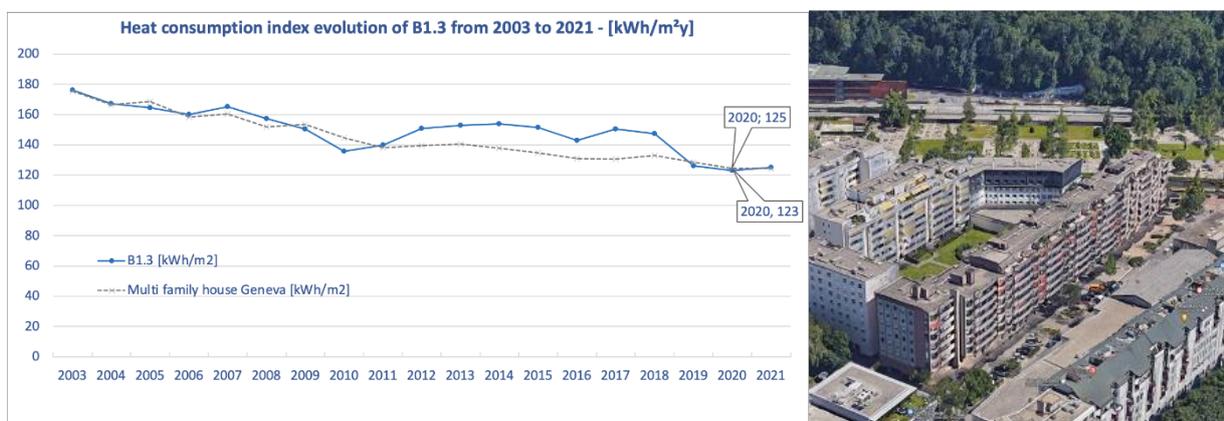
**Figure 3: Annual final heat consumption evolution of B1.3**

Building B1.3 is a large building from the 1980s with high energy consumption, which will not be renovated during the next 15 years. This building provides a good opportunity to evaluate low-performing buildings and assess simple behavioural changes and their impacts on energy consumption.

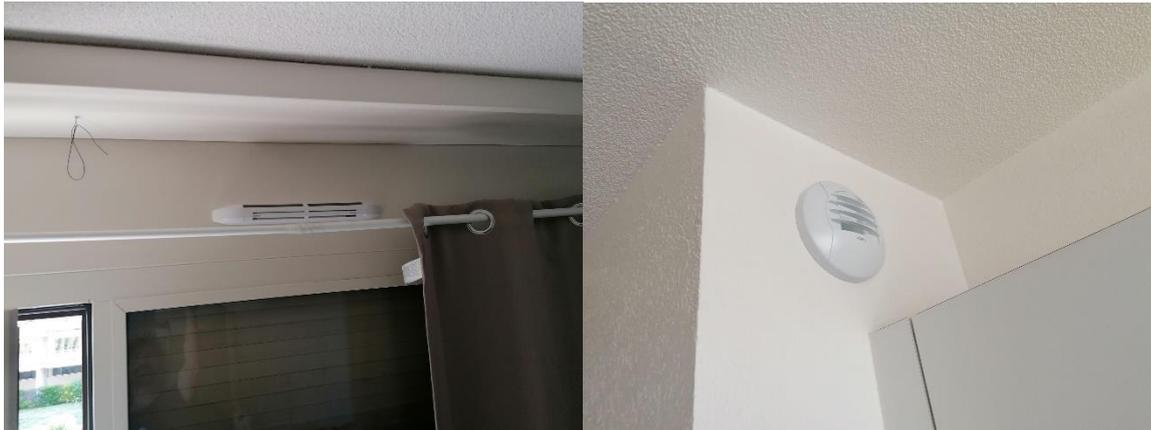
The building ventilation system was initially a simple mechanical extraction with two-speed control and a night stop for some parts of the building. Each building entrance had an independent ventilation system with a nominal power of 1.1 kW. Those ventilation systems were replaced in April 2022 by humidity-sensitive ventilation systems. In this system, the air inlet and exhausts' opening position depends on the room's humidity, allowing the airflow to be adapted to the room's needs. Examples of inlet and exhaust valves are shown in Figure 4.

**Figure 4: Humidity-sensitive inlet and exhaust valves installed in B1.3**

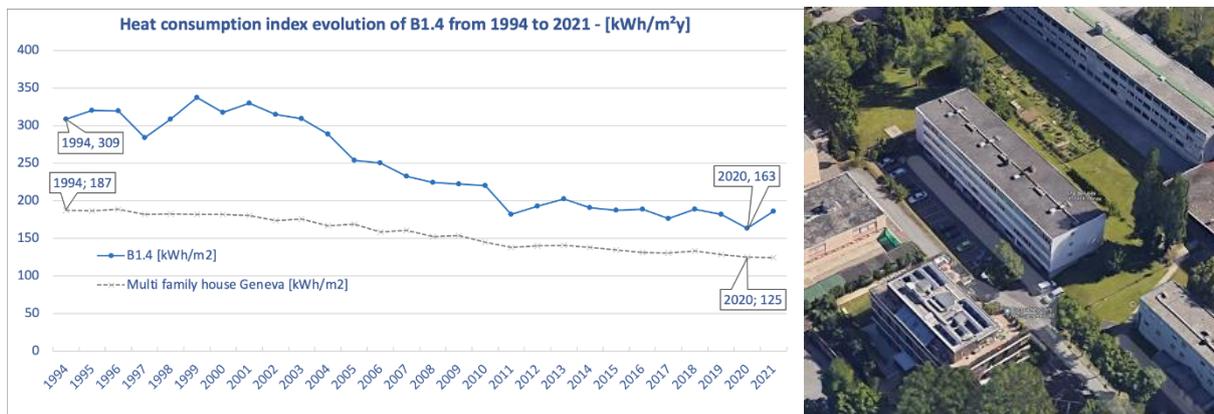
**Figure 5: Annual final heat consumption evolution of B1.4**

Building B1.4 is a typical building of the 1960s, which is not insulated and has a significant energy demand for heating. There is a refurbishment project ongoing on this building. It was initially selected for this reason as it would have been interesting to follow the indoor air quality (IAQ) during the refurbishment work. However, local legislation and constraints delayed the project to 2025, which means that a renovation roadmap can be proposed before the refurbishment work. However, it will not be possible to evaluate if there is a performance gap after the refurbishment before the end of the project.

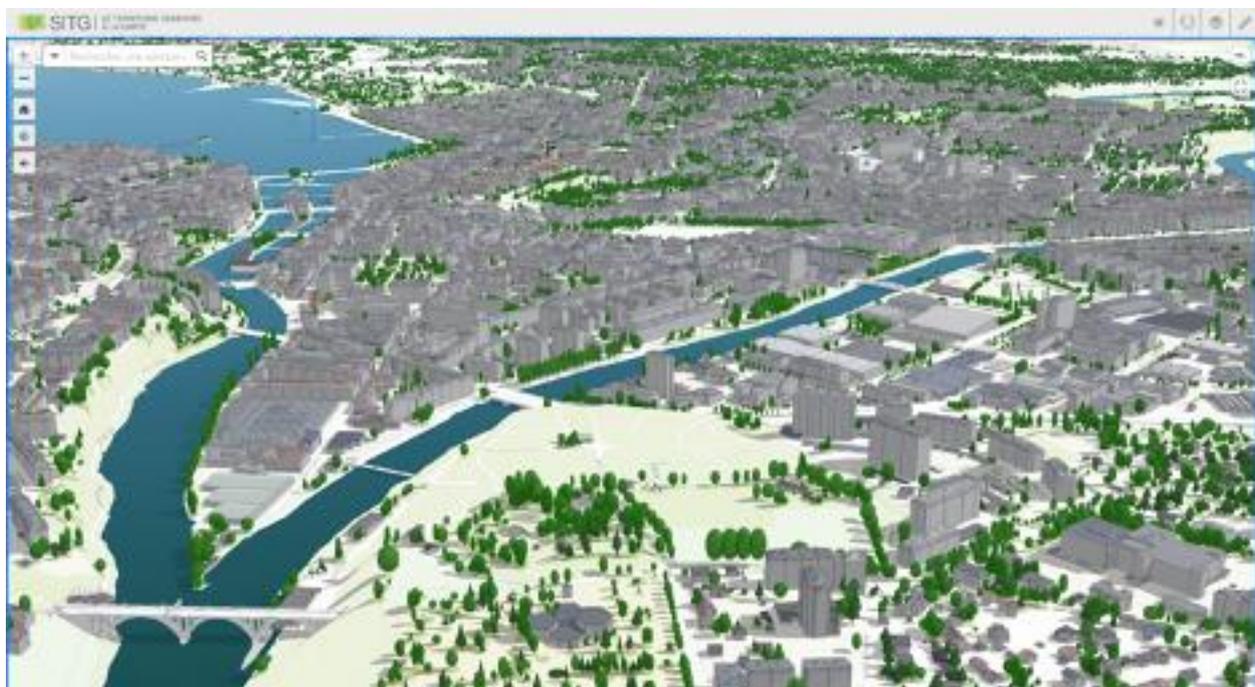
**Figure 6: Geneva canton 3D cadastre gives surface areas of facades, roofs, or heated reference areas.**

The annual  $E_{\text{HW}}$  value is available on the well-documented and rich cantonal GIS public system, an interface of which is presented in Figure 6. Furthermore, GIS services include an extensive range of other information, not only dimensional, like the façade, roof, footprint surface areas of the building, but also energy data, like the boiler size and date of installation, the photovoltaic potential, and thermographic views of roofs, etc. In the framework of the E-DYCE project, two categories of public GIS information are found interesting and relevant:

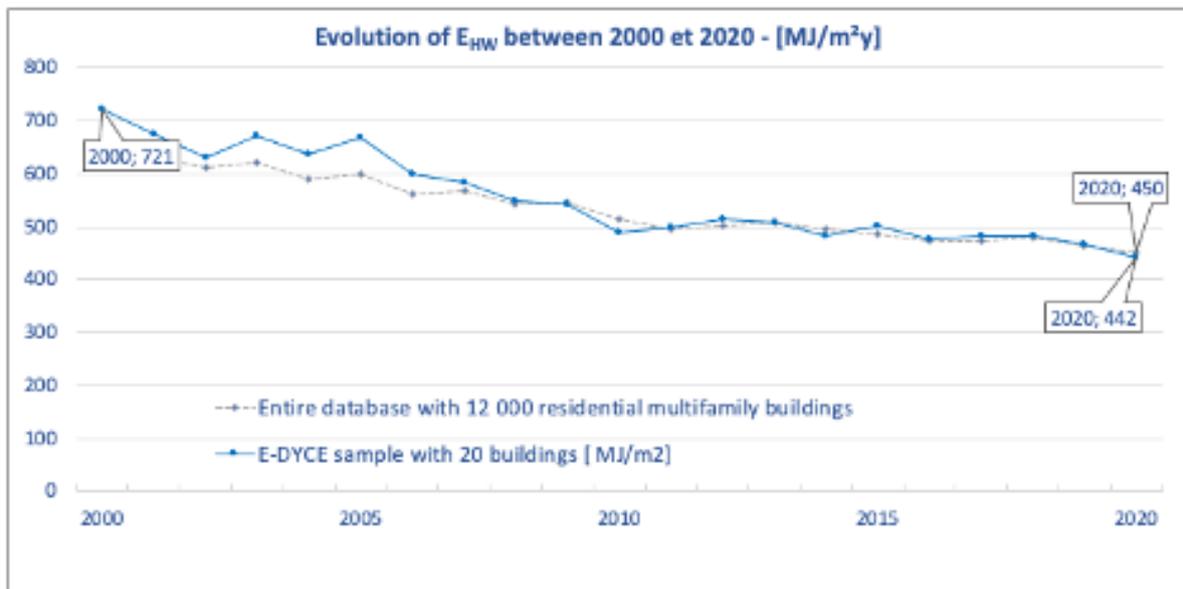
**Figure 7: Evolution of the EHW of the E-DYCE sample and the entire Geneva building stock of residential buildings since 2000.**

20 buildings, where policies can be evaluated. The small sample was selected to have the main refurbishment and optimization contexts. The large sample was selected to represent Canton’s entire building stock, as demonstrated in Figure 7.

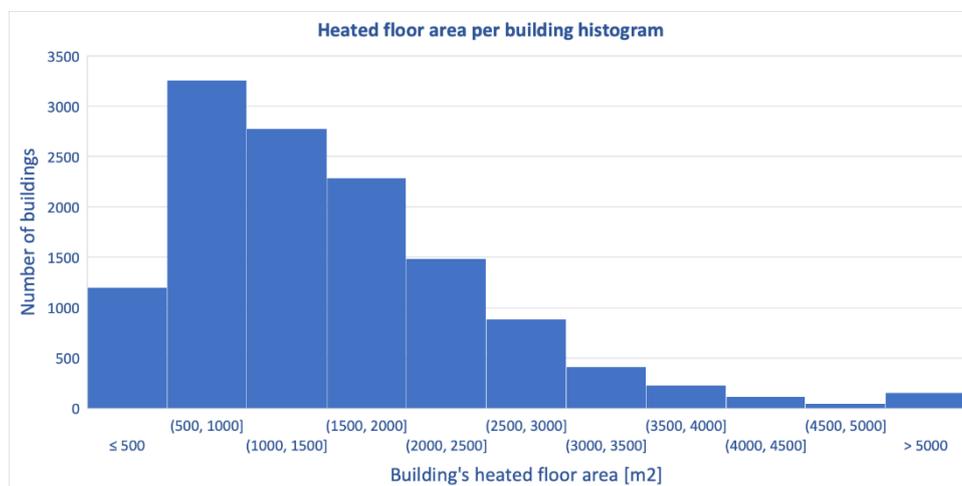
**Figure 8: Heated floor surface area per building in Geneva’s GIS database**

The four individual buildings are typical apartment buildings, which typology represents ~60% of the heated area of the Canton, as observed in Figure 8. The selected cases serve the following main objectives:

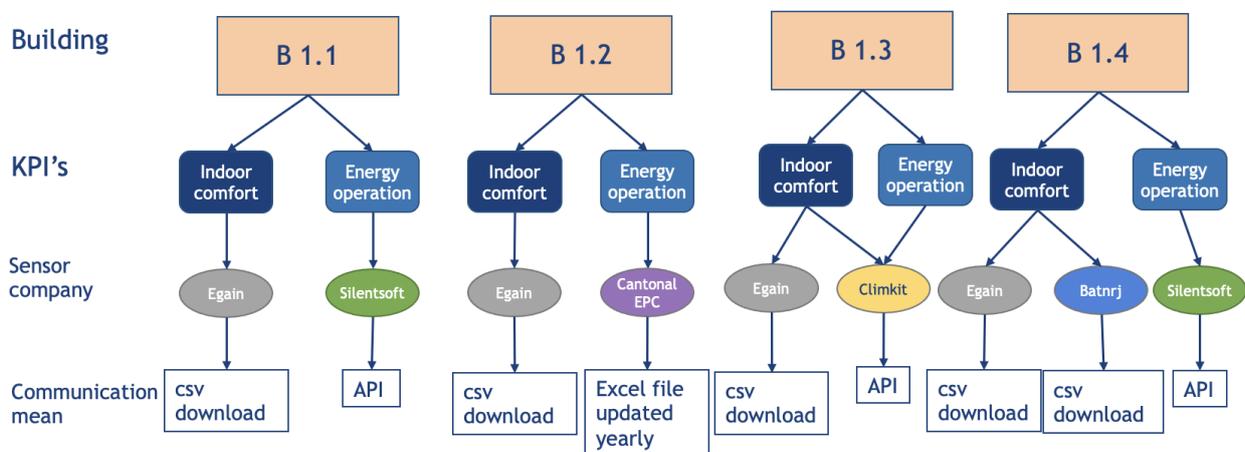
Figure 9: Monitoring quantities and systems for the case studies

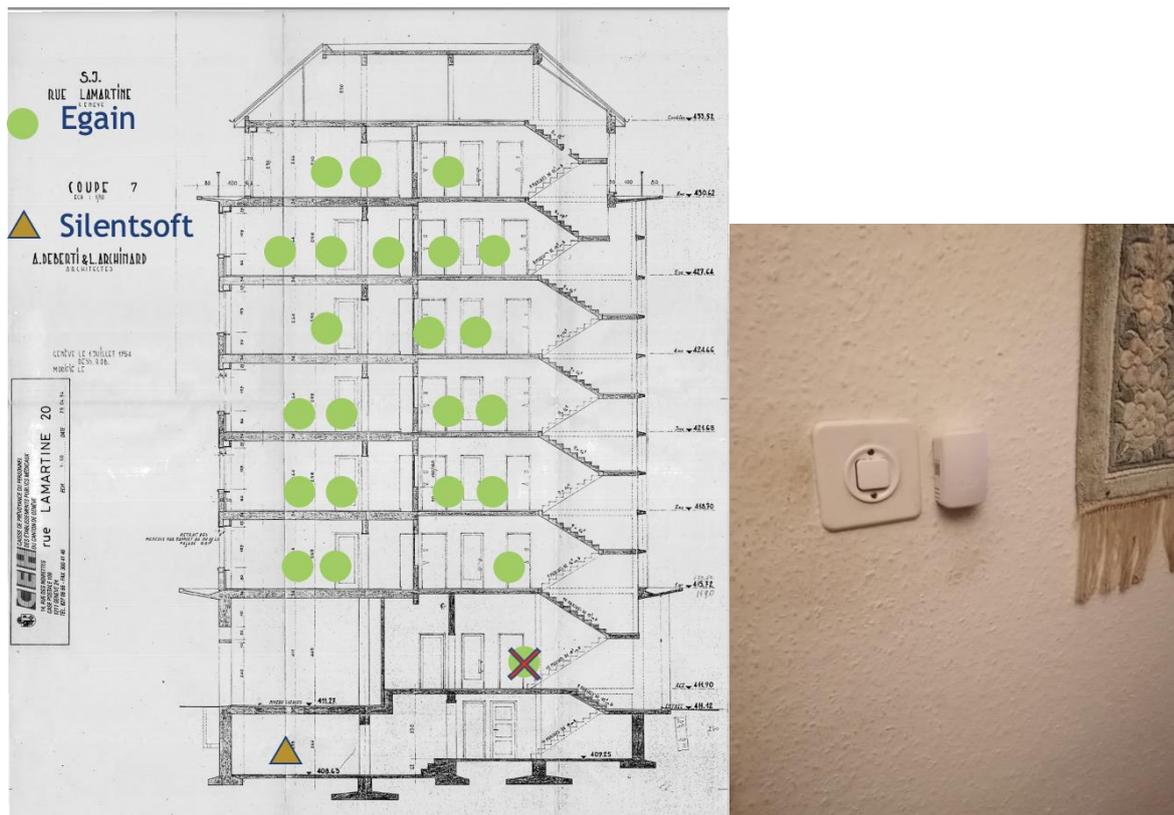
Figure 10: B1.1 (a) Egain probes position in the building and (b) view of a single Egain sensor installed in an apartment

The monitoring of B1.1 consists in following the indoor environment with Egain probes (22) and the heat consumption with a Silentsoft probe. This allows following the general consumption for heating and DHW. We are, however, missing the DHW production energy of the thermal solar panels on the roof of the building. This will lead to a lack of information and analysis material.

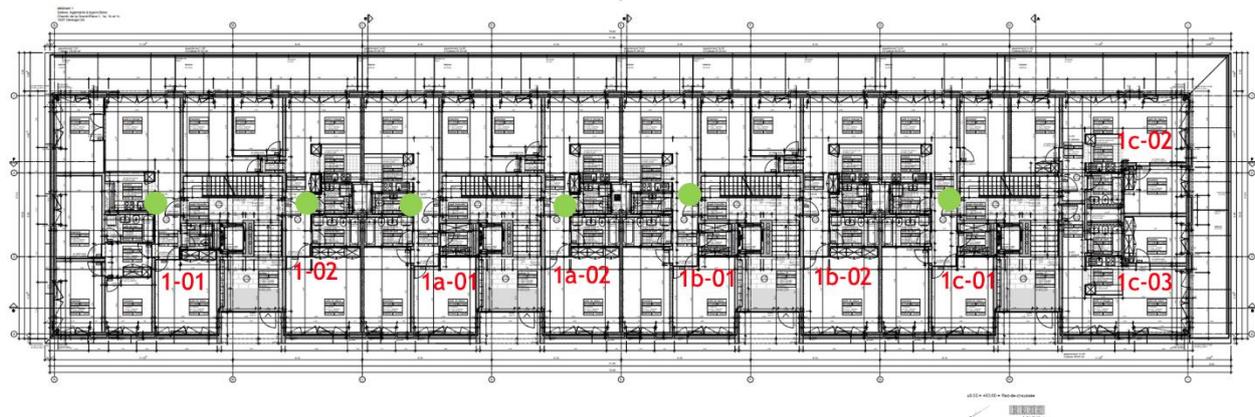
**Figure 11: B1.2: Position of Egain probes on a typical floor**

The already existing Egain probes were used to monitor the thermal comfort conditions in B1.2. As the probes also measure relative humidity, they can be used for general analysis of indoor air quality. As presented in Figure 11, almost all apartments were monitored for hygrothermal conditions, so no additional sensors were added.

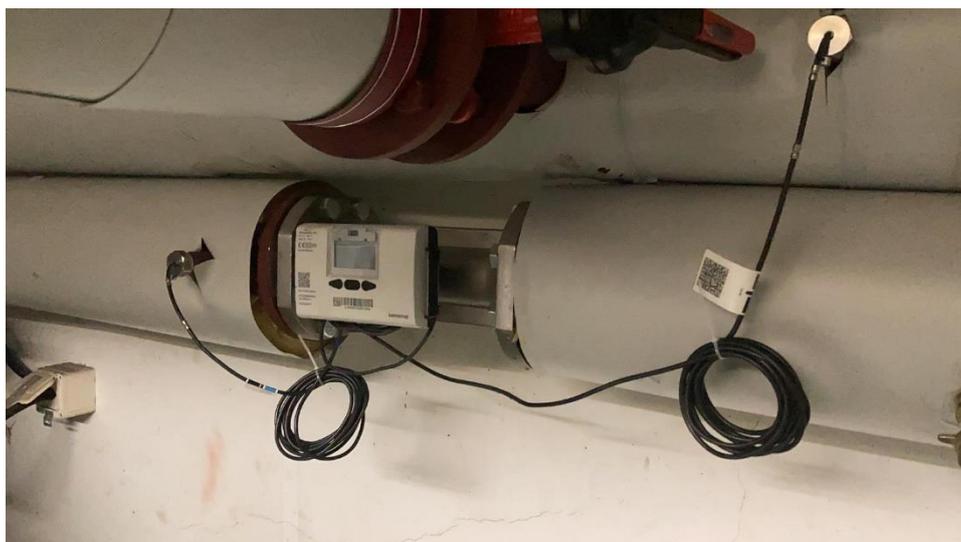
**Figure 12: B1.3: Installed heat counter**

This building was the only one that had no monitoring before the beginning of the project. So, to monitor the energy consumption, two heat counters were ordered, one for the total heat production from the heater and one for the DHW production. The delivery of the counter got importantly delayed by the shortage of electrical components. Additionally, the position of the heater (in the second basement of the building) did not allow an adequate internet connection, which delayed the commissioning of the two counters again. Initially ordered in May 2021, the counters' commissioning date was the 6<sup>th</sup> of May 2022. A view of the installed heat counter is presented in Figure 12.

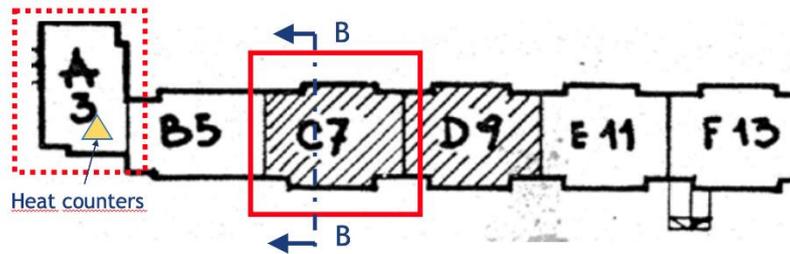
**Figure 13: B1.3: Monitored part of the building**

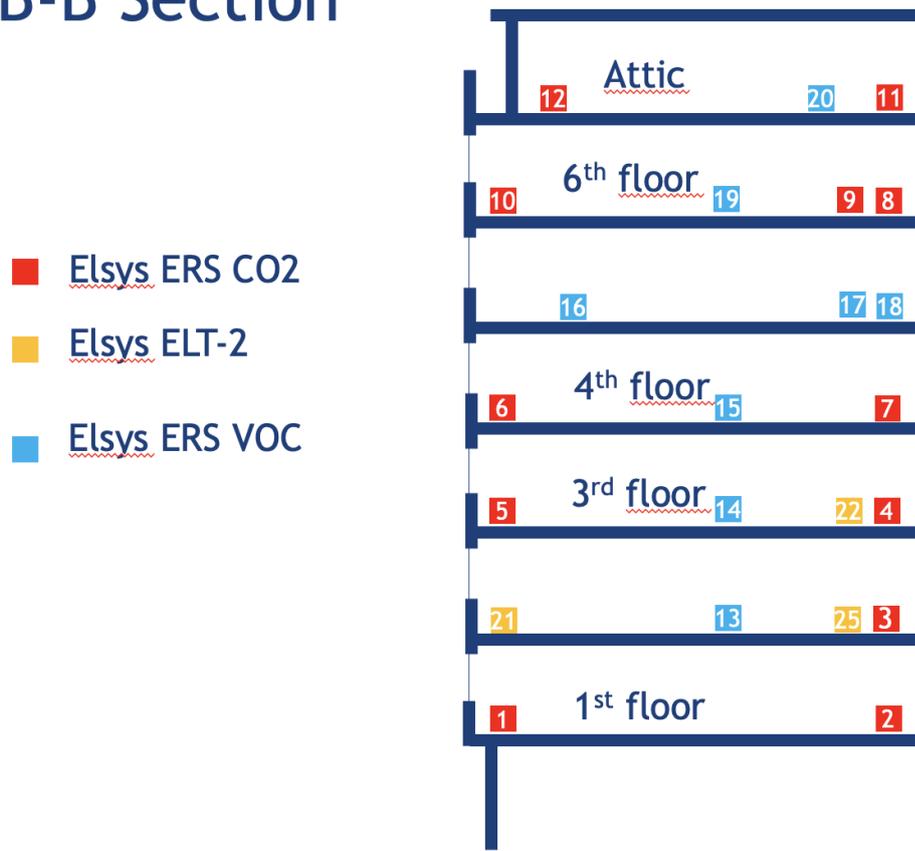
Figure 14: B1.3: Position of the probes in building entrance 7

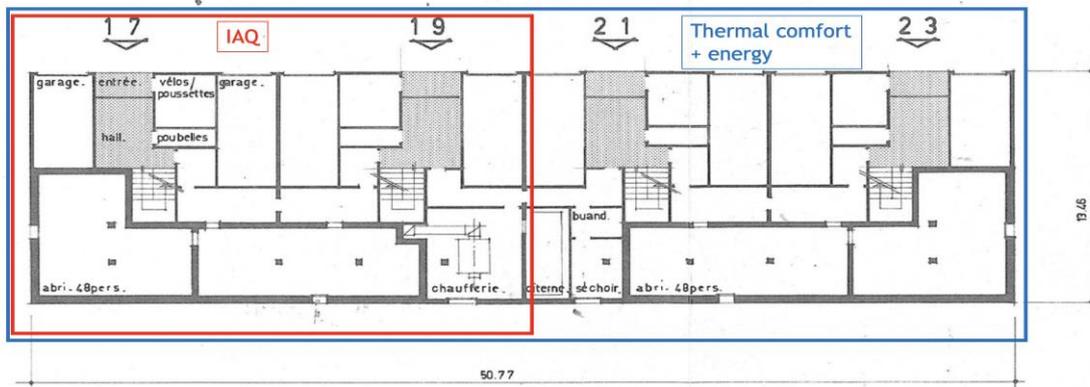
Figure 15: B1.4: Monitored building part

Similarly to B1.3, a monitoring solution with a movable gateway was chosen. Although the system is not the same as for B1.3 (BatnrJ and not Climkit), the principle of a gateway communicating to different sensors through LORA is the same. Here again, the range of the LORA antenna did not allow for a clean IAQ monitoring of the whole building. The decision was taken to monitor half of the building, as presented in Figure 15, for IAQ so that probes could communicate with the central gateway.

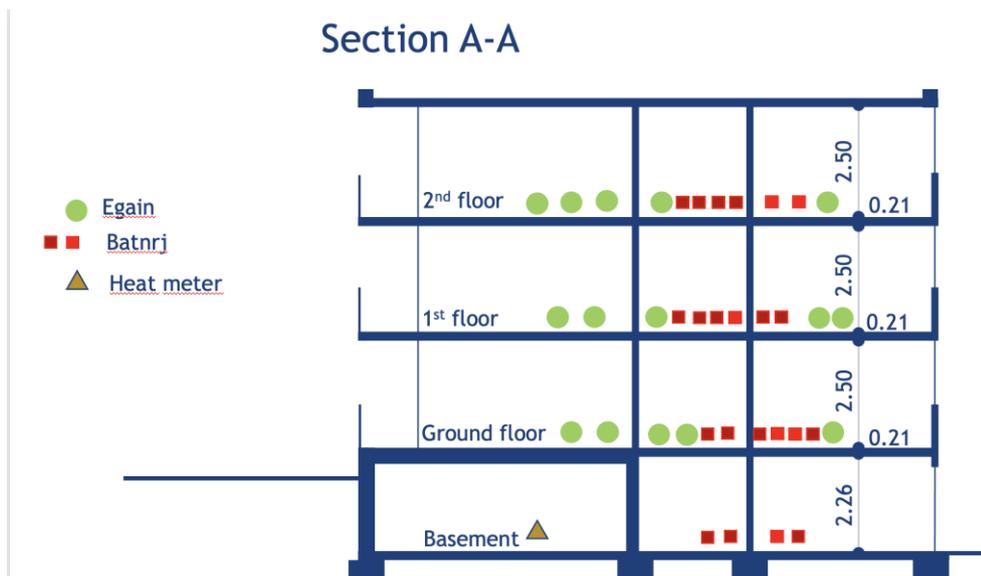
Figure 16: B1.4: repartition of the probes in the building

As presented in Figure 16, two probes were installed in the monitored apartments, one in the master bedroom and one in the living room. This allowed the identification of local discrepancies between the rooms.

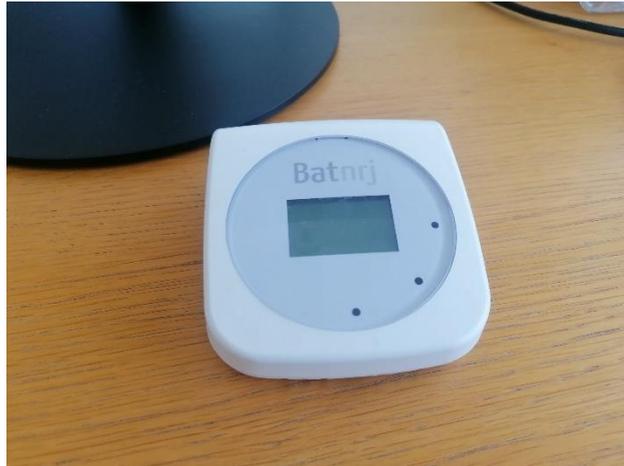
**Figure 17: B1.4: Batnrj sensor example**

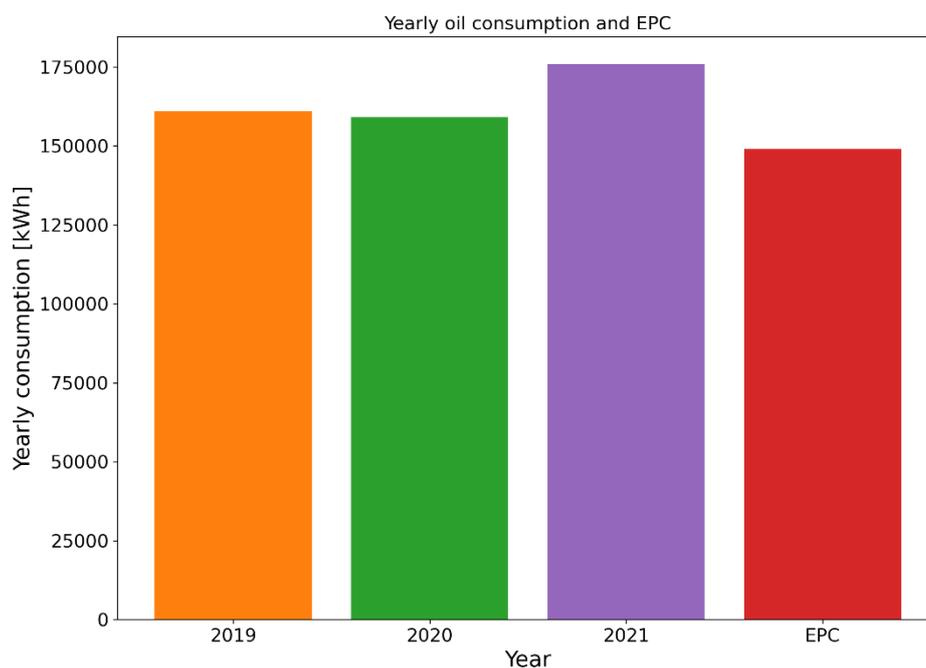
Despite some parts of DHW production not being taken into consideration, the building consumed more energy than expected by the EPC, as it is shown in Figure 18. The performance gap is, therefore, already visible without adding the DHW production from the solar panels, outlining its importance.

**Figure 18: B1.1: Final energy consumption for space heating and DHW from the oil-boiler, compared to EPC final energy estimation**

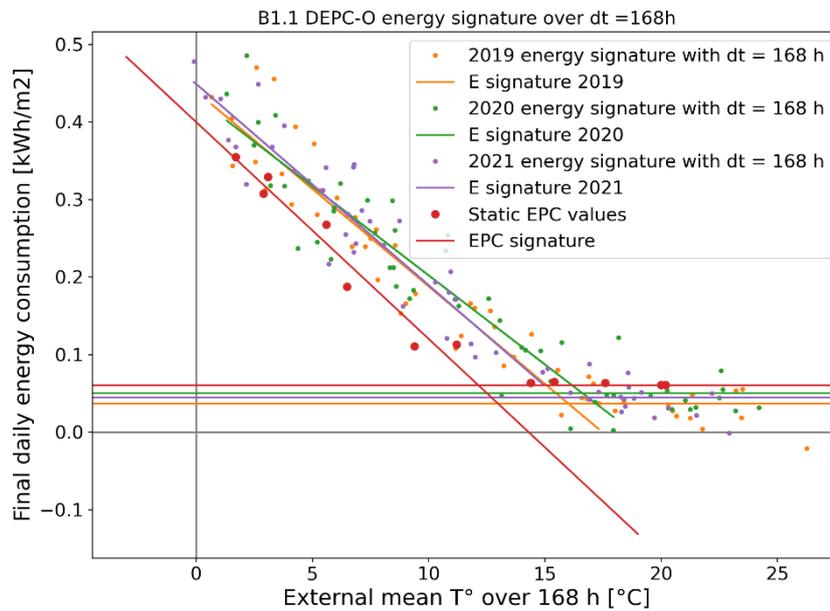
Two interesting results can be identified by observing the energy signature from the oil consumption, presented in Figure 19. First, some DHW production energy from the solar panels is, in fact, missing. The constant part for all three years of data is below the standard value given by the EPC. In most cases (see B1.4, for example), DHW production energy exceeds the standard value. This outlines the lack of information coming from the absence of DHW production from the solar panels.

The second result is visible on the left part of the energy signature, outlining the higher energy need for low external temperature than expected from the EPC. The slope appears to be of the same order, and the difference can therefore be attributed to higher DHW production needs in the cold season when the solar panels are less efficient. However, this does not explain everything. Further analysis should be performed with DHW data.

**Figure 19: B1.1: Energy signature for final energy consumption of the oil-boiler over 168h time interval. The y axis was normalized to daily consumption/m2 of floor heated surface area of the building**

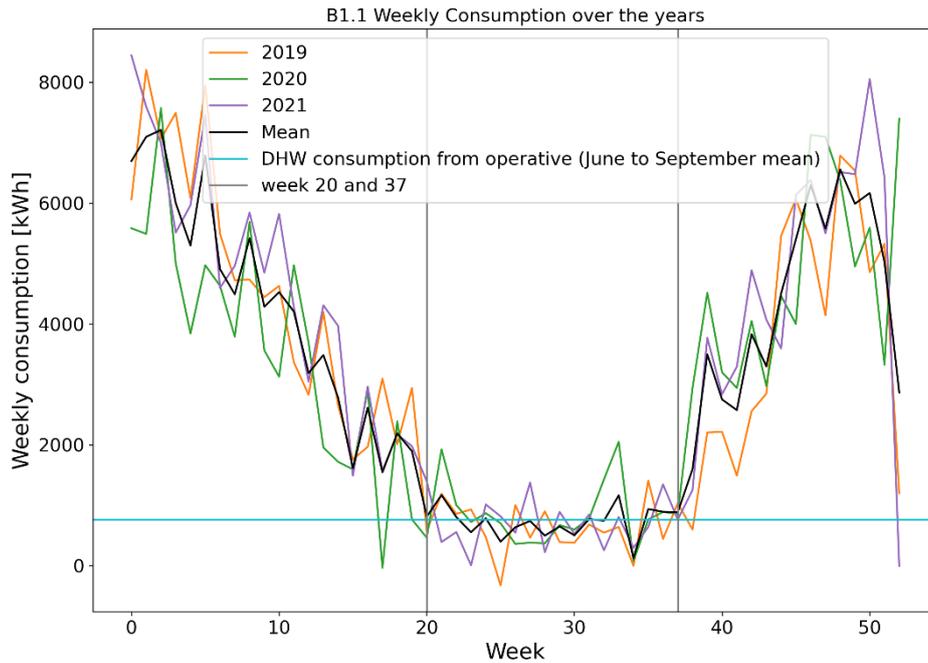
Figure 20 presents the evolution of oil consumption over the weeks of the year. It can be observed the free-running period of the building is between weeks 20 and 37 of the year.

**Figure 20: B1.1: Weekly final energy consumption for the oil boiler over the years**

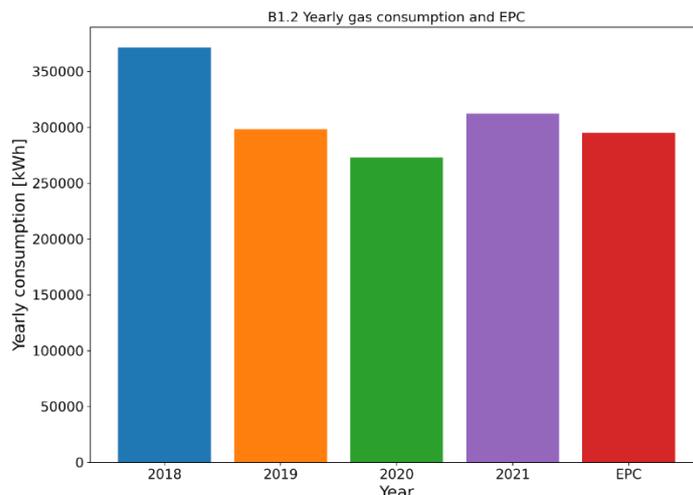
**Figure 21: B1.2: Final energy consumption for space heating and DHW from the gas-boiler, compared to EPC final energy estimation**

Building B1.2 showed a substantial performance gap from its commissioning in 2012-2013. However, since 2019, its energy consumption has been reduced, as observed in Figure 21. The energy consumption data are coming from the monthly gas delivery invoices. The SIG (gas deliverer for Geneva city) already translates the gas in kWh.

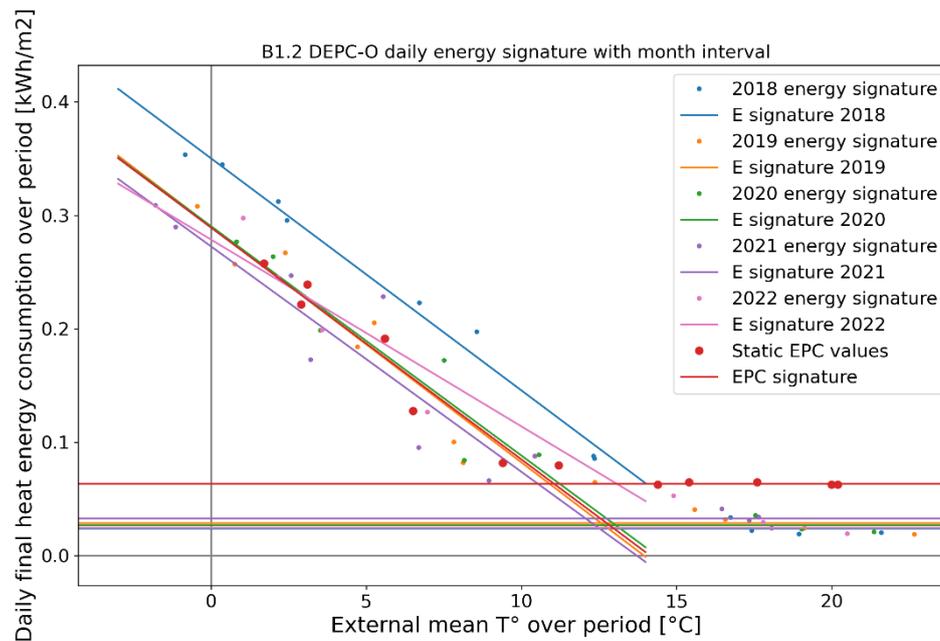
Just like B1.1, we are missing the DHW production data of the solar panels. This energy should be added to the consumption compared with the EPC. From the energy signature presented in Figure 22, we can evaluate that at least half of the DHW production is done by the solar panels, at least during summer.

When observing the energy signatures over the different years, an important difference between 2018 and the following years is visible. The reason for this gap is still uncertain and is subject to investigation. However, several HVAC companies have been in charge of the building over the years, and the information takes time to recover.

**Figure 22: B1.2: Energy signature for final energy consumption of the gas-boiler over 168h time interval. The y-axis was normalized to daily consumption/m<sup>2</sup> of floor heated surface area of the building**

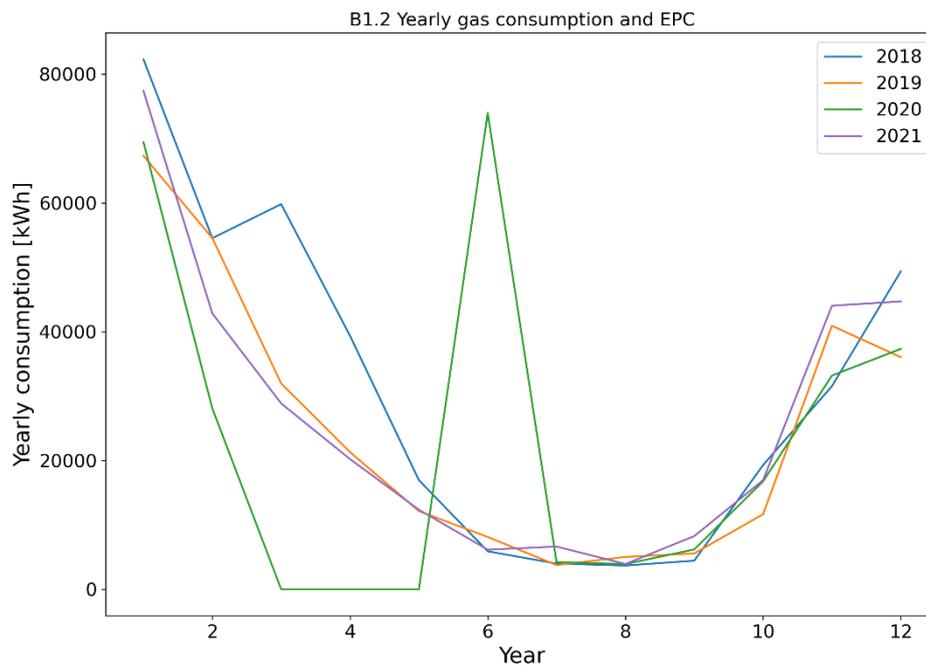
**Figure 23: B1.2: Monthly final energy delivery for the gas boiler over the years.**

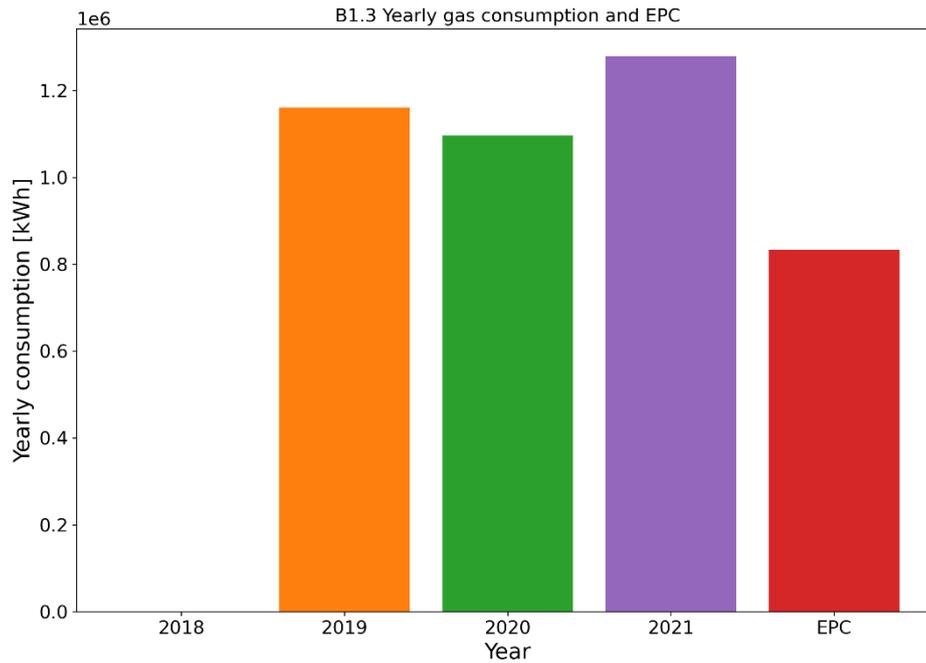
**Figure 24: B1.3: Final energy consumption for space heating and DHW from the gas-boiler, compared to EPC final energy estimation**

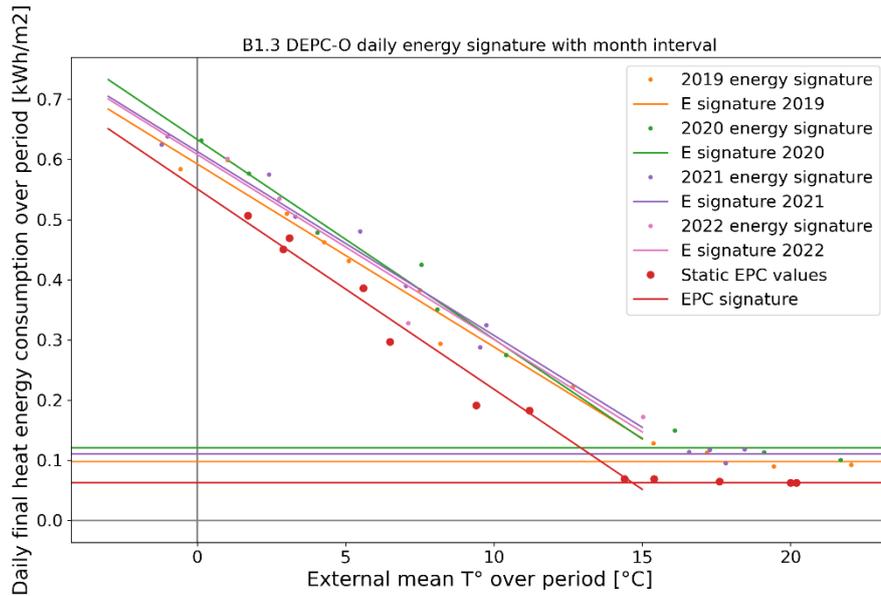
**Figure 25: B1.3: Energy signature for final energy consumption of the gas-boiler over 168h time interval. The y-axis was normalized to daily consumption/m2 of floor heated surface area of the building**

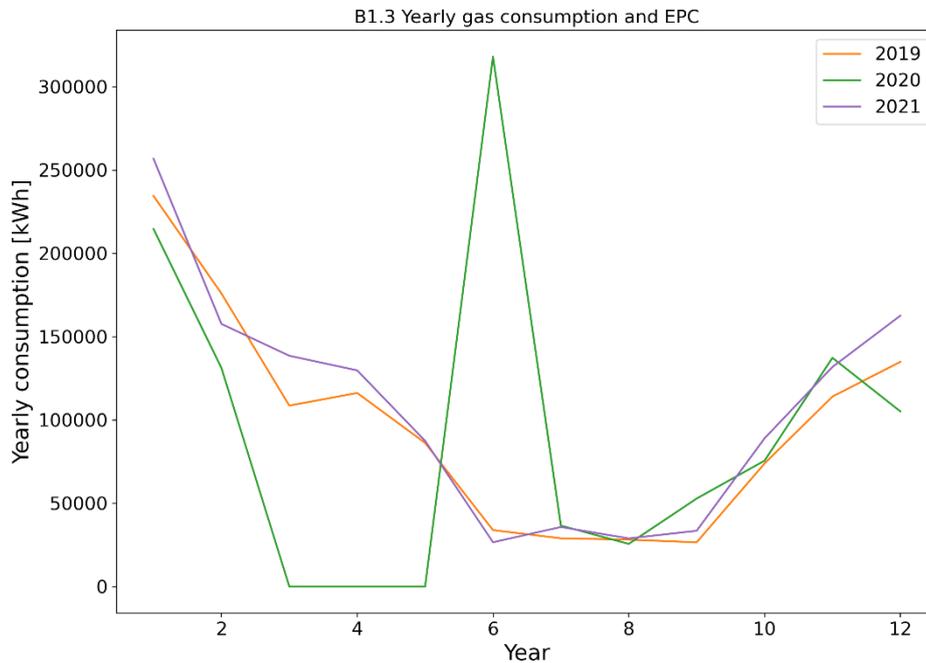
**Figure 26: B1.3: Monthly final energy delivery for the gas boiler over the years.**

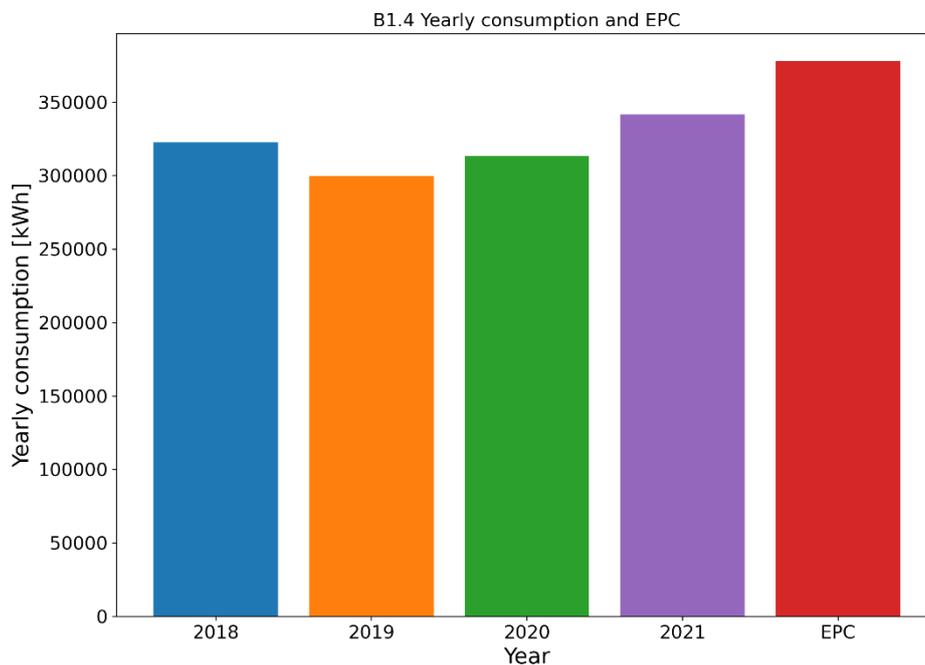
**Figure 27: B1.4: Final energy consumption for space heating and DHW from the oil-boiler, compared to EPC final energy estimation**

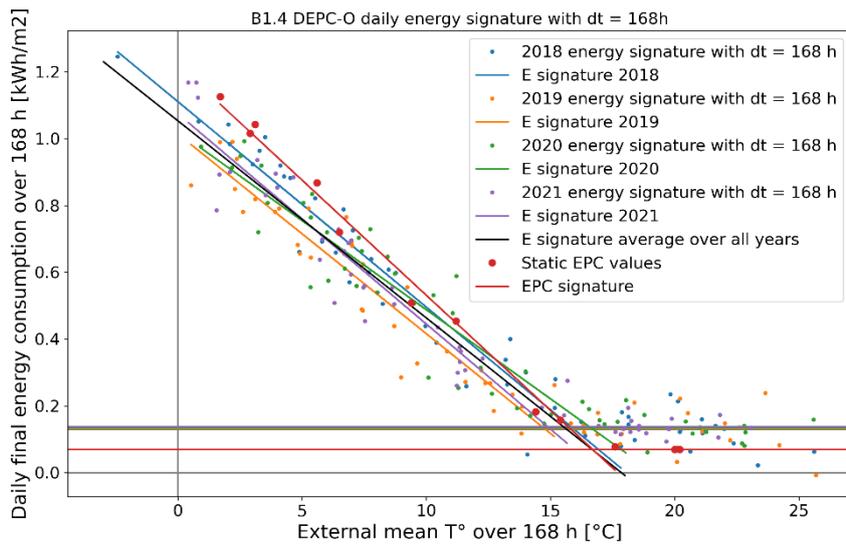
This comparison over different years does not represent well the building characteristics as it lacks the dependency on the outdoor air temperature. For this purpose, an energy signature with respect to the outdoor temperature is shown in Figure 28. This allowed us to evaluate if the building performs differently with respect to the outdoor condition as it was anticipated in the EPC:

**Figure 28: B1.4: Energy signature for final energy consumption of the oil-boiler over 168h time interval. The y axis was normalized to daily consumption/m2 of floor heated surface area of the building**

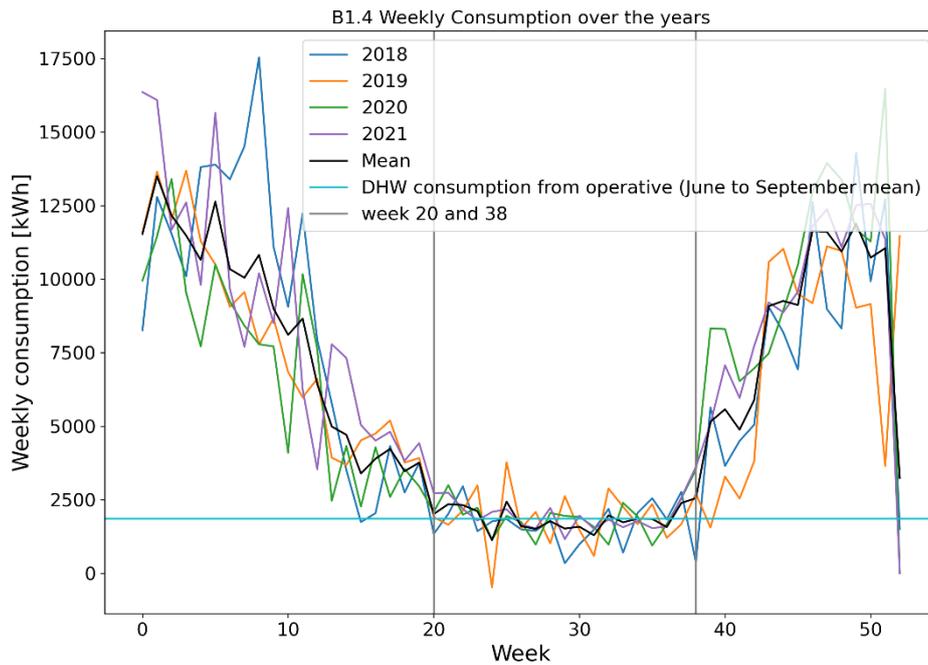
Figure 29: B1.4: Weekly final energy consumption for the oil boiler over the years

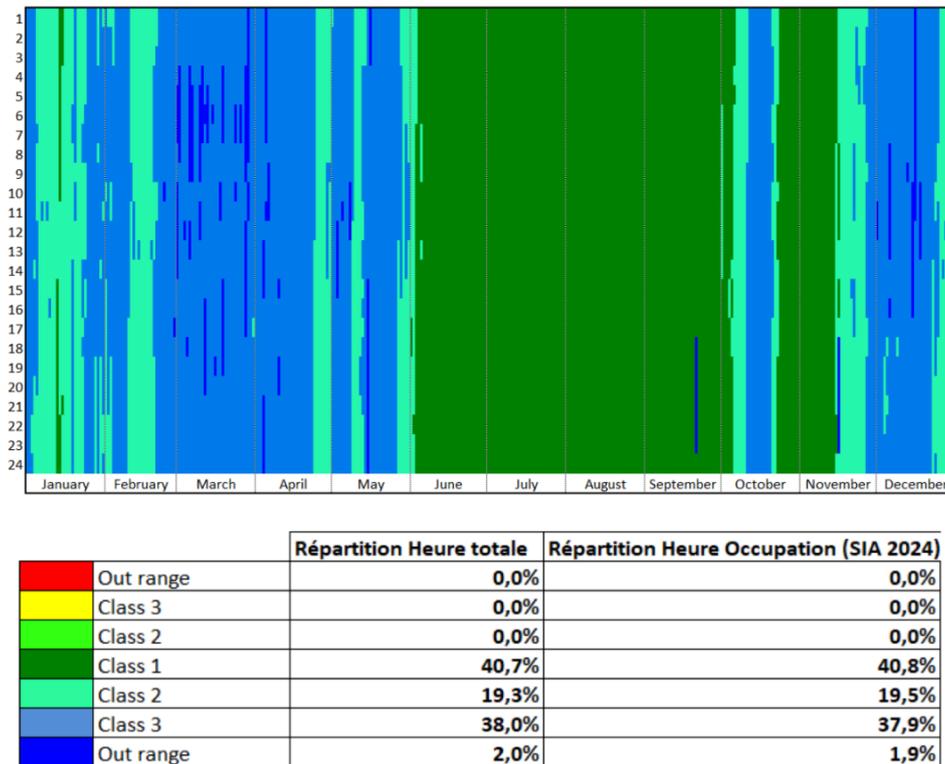
Figure 31: B1.2: Carpet diagram of thermal comfort for an extreme apartment location (ground floor)

The building seems to work at optimal conditions to allow strict comfort, thanks to the heating optimization of Egain.

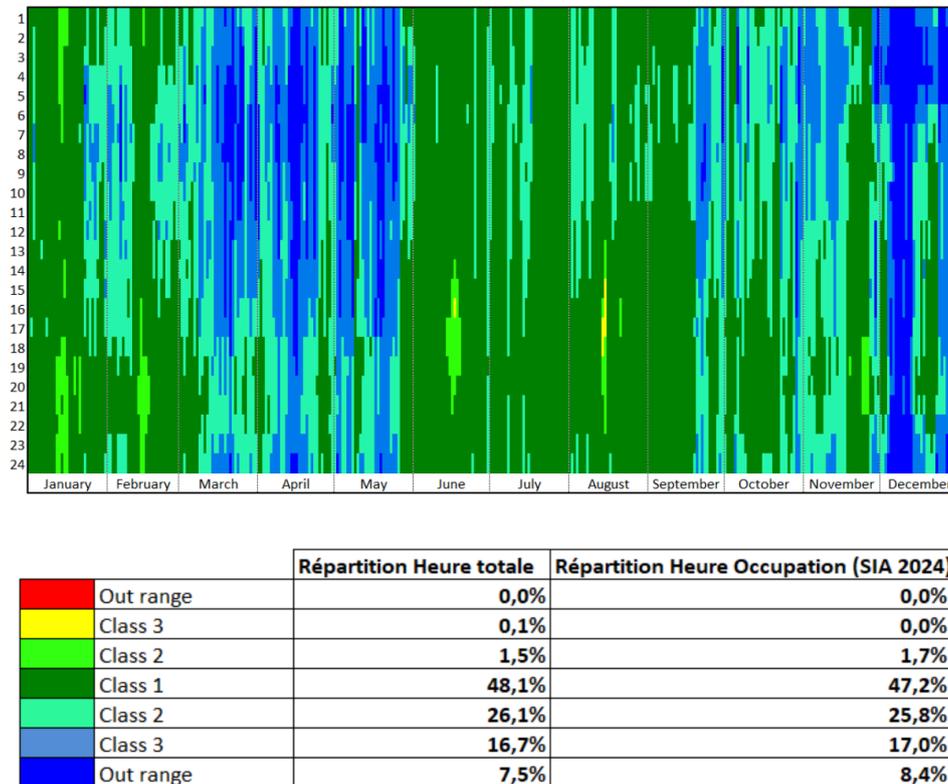
Figure 33: B1.4: Carpet diagram of thermal comfort for an extreme apartment location (1st floor, North)

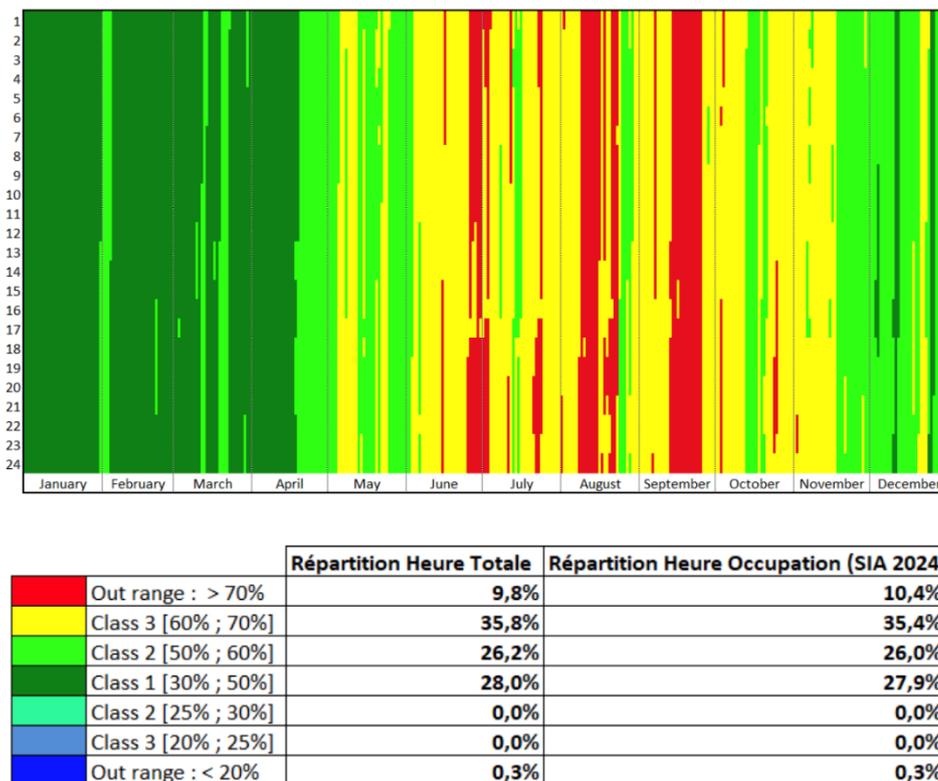
Figure 34: B1.1: Carpet diagram of relative humidity for an extreme apartment location (1st floor)

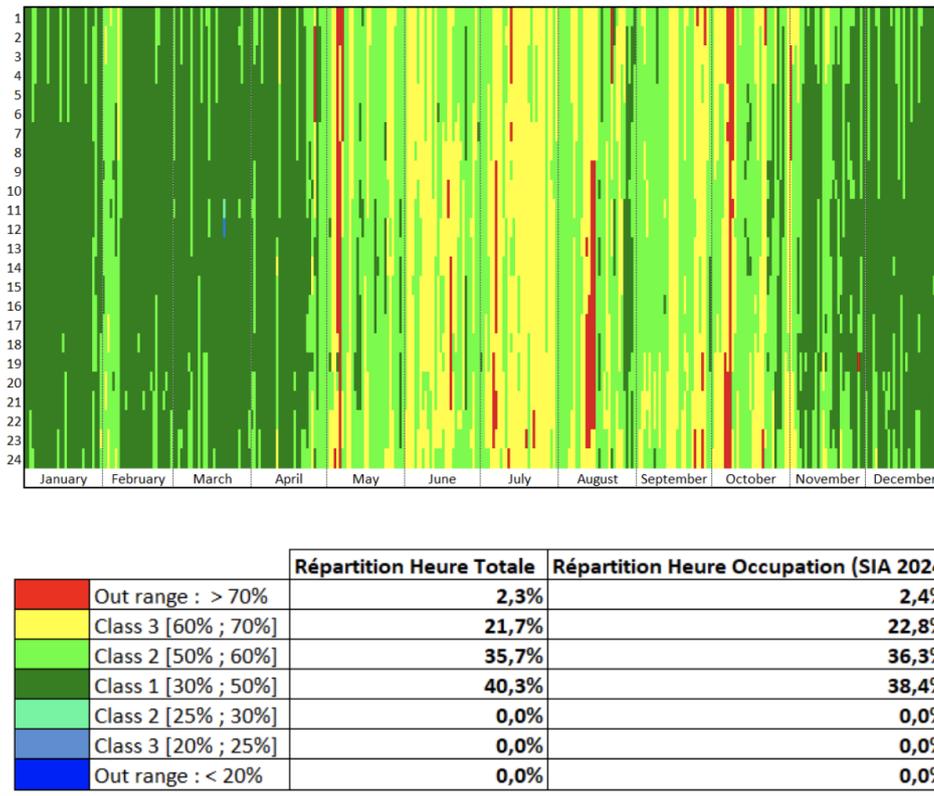
**Figure 35: B1.2: Carpet diagram of relative humidity for an extreme apartment location (4th floor)**
