**Project full title:** Energy flexible DYnamic building CErtification

Deliverable number:	<b>D5.2</b>
Deliverable title:	<b>Geneva case study report #1 and #5 Geneva</b>
Work package:	WP5
Due date of deliverable:	M24
Actual submission date:	M25 - 01/09/2022
Start date of project:	01/09/2020
Duration:	36 months
Reviewer(s):	Daniel Leiria (AAU)
Author/editor:	Laurent Tippenhauer (OCEN)
Contributing partners:	ESTIA

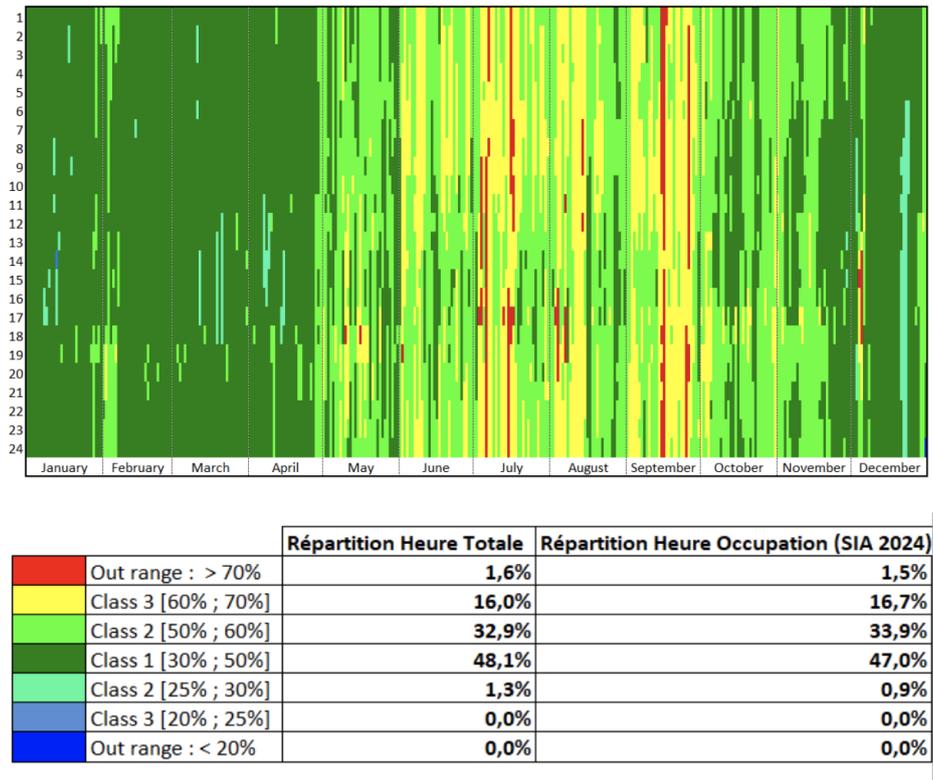
Figure 37: B1.4: Carpet diagram of relative humidity for an extreme apartment location (4th floor)

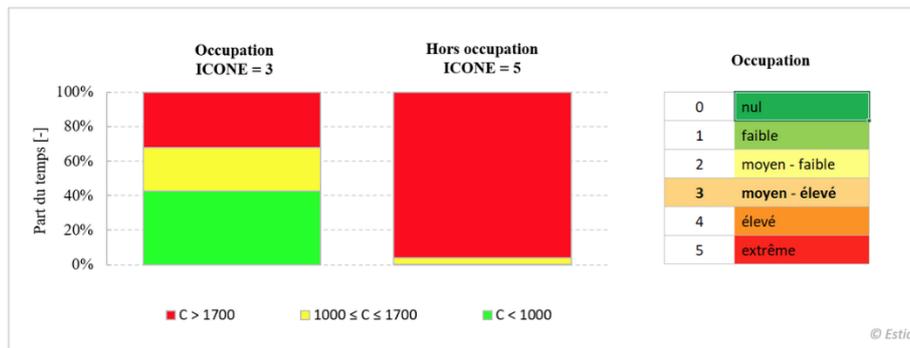
**Figure 38: B1.4: Extreme ICONE result of a monitored apartment (last floor)**

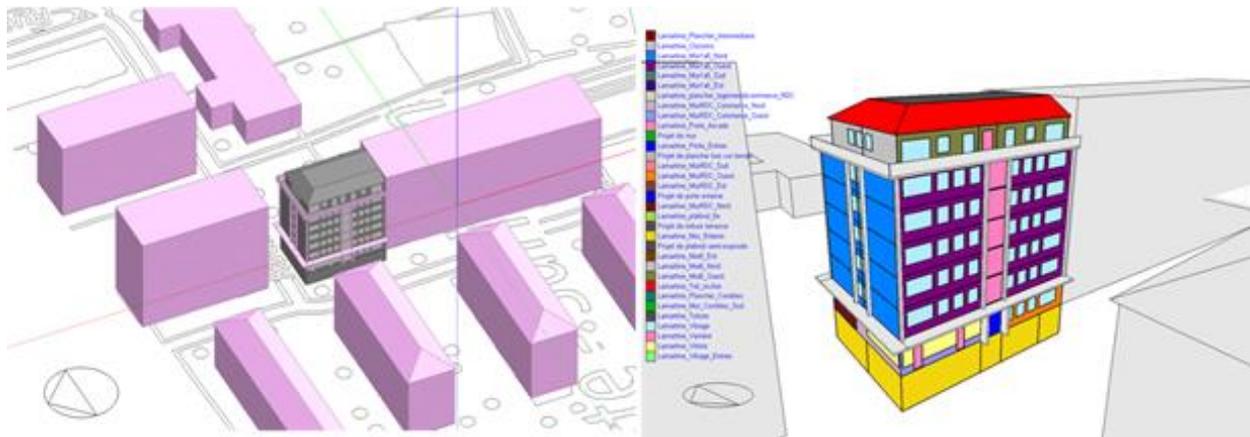
**Figure 39: External views of the B1.1 presenting the external geometry of the investigated and neighbouring buildings.**

Figure 39 presents the model's geometry, while Figure 40 presents the thermal zones of the typical floor.

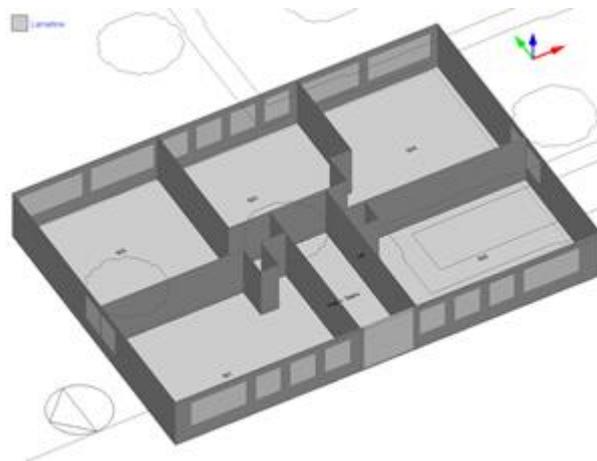
**Figure 40: View of the model's thermal zones for a typical floor of B1.1.**

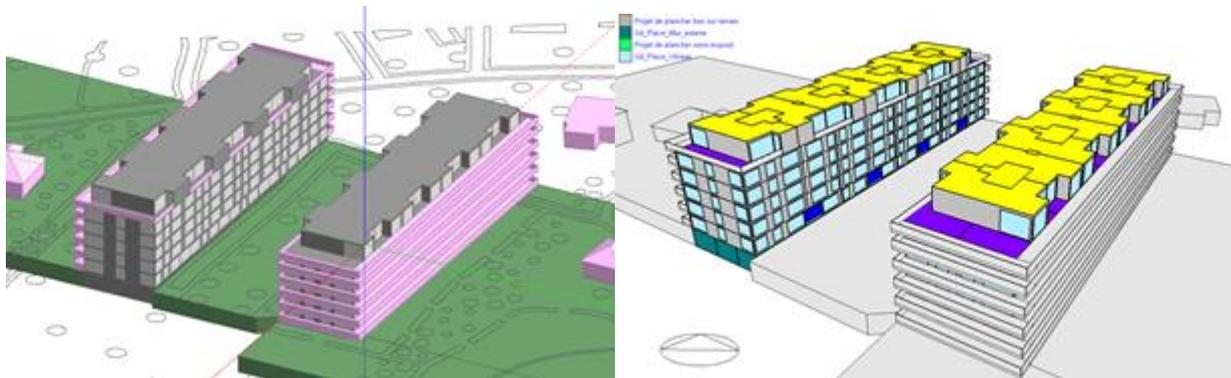
Figure 41: External views of the B1.2 presenting the external geometry of the investigated and neighbouring buildings.

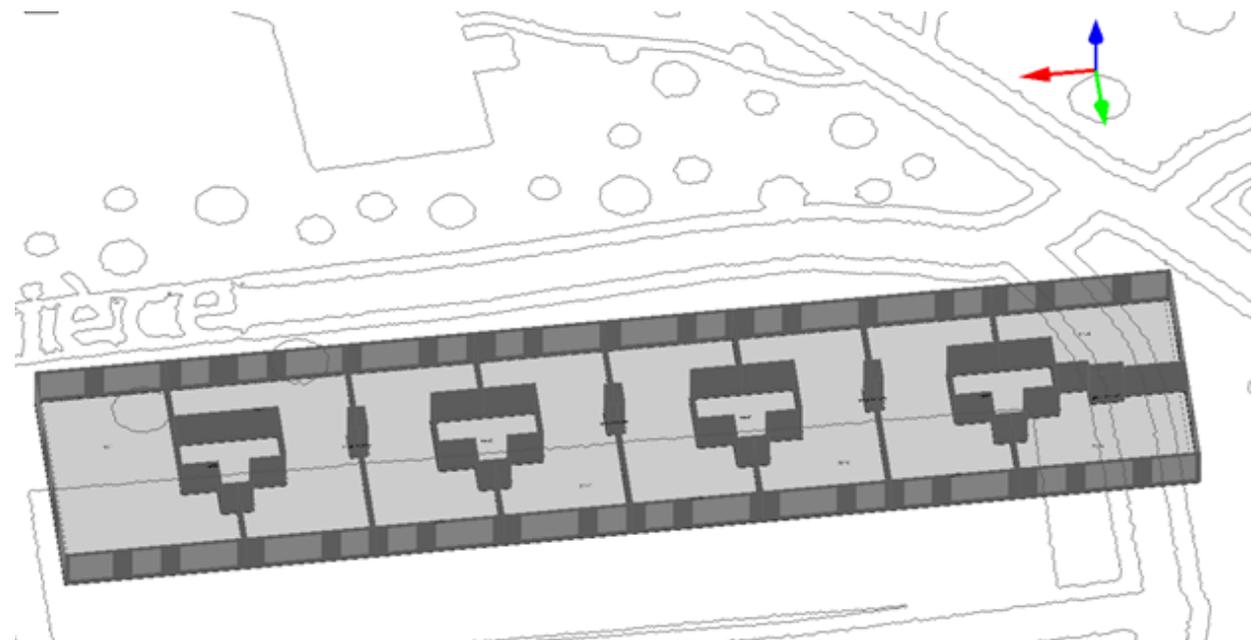
Figure 42: View of the model's thermal zones for a typical floor of B1.2.

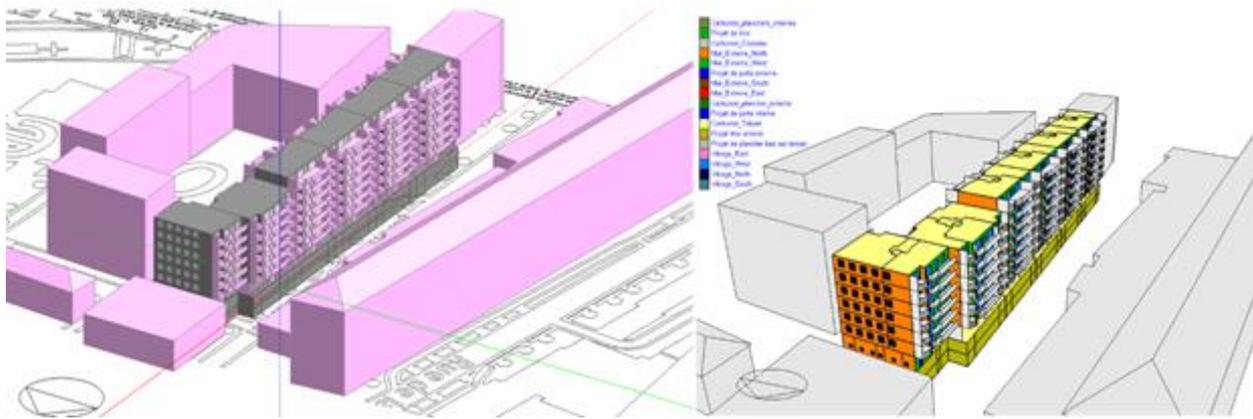
Figure 43: External views of the B1.3 presenting the external geometry of the investigated and neighbouring buildings.

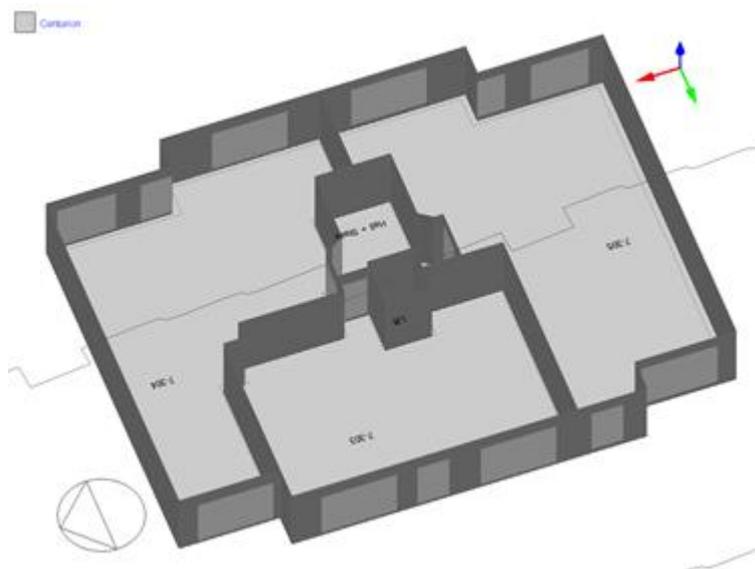
Figure 44: View of the model's thermal zones for a typical floor of B1.3.

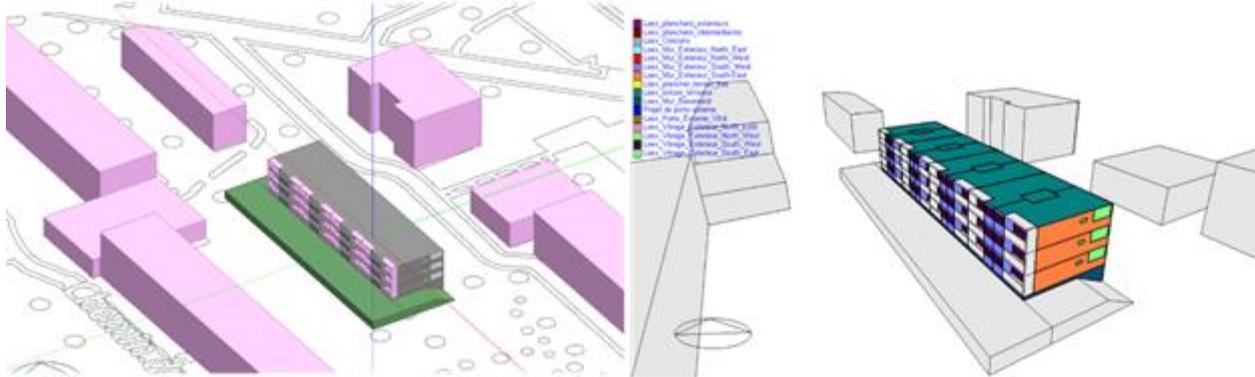
**Figure 45: External views of the B1.4 presenting the external geometry of the investigated and neighbouring buildings.**

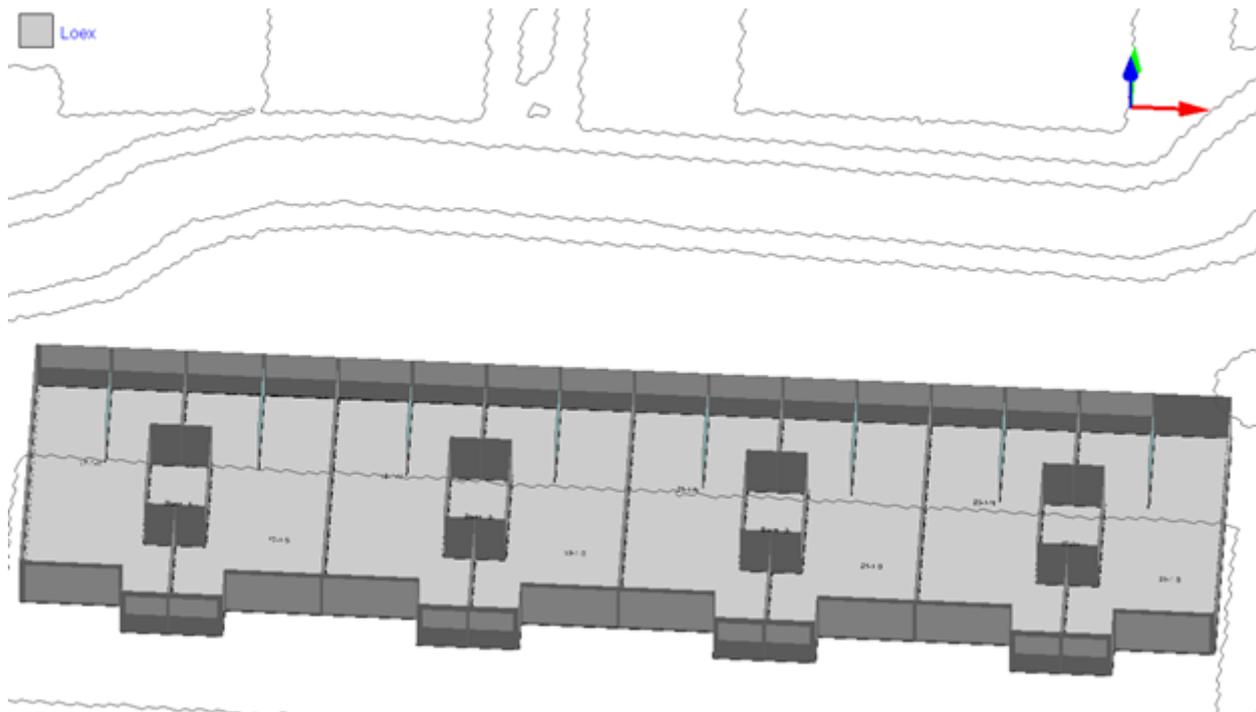
**Figure 46: View of the model's thermal zones for a typical floor of B1.4.**

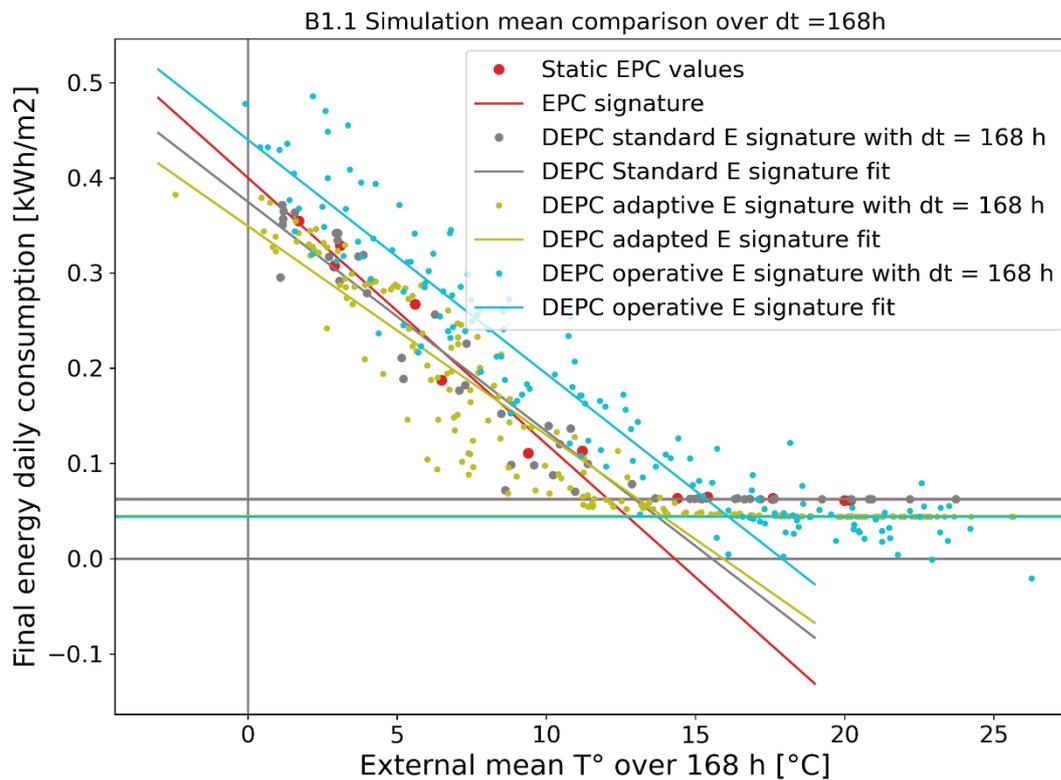
**Figure 47:** Energy signature as a result of the tested EPC schemes for the B1.1.

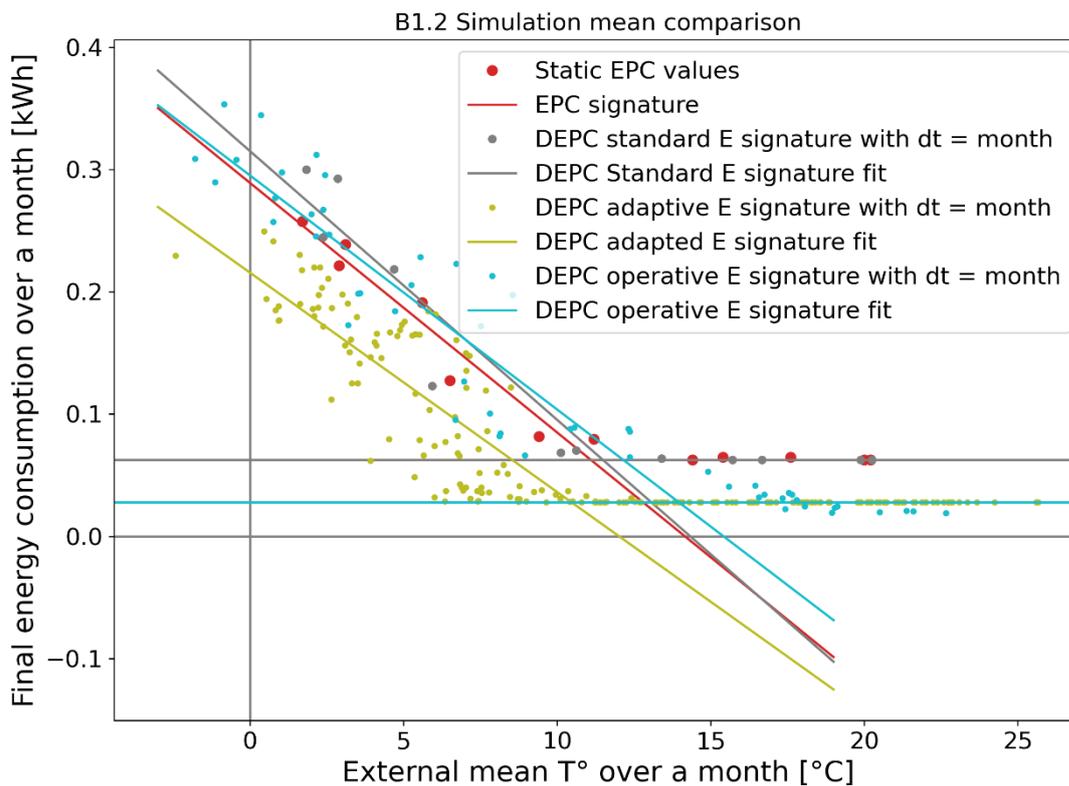
Figure 48: Energy signature as a result of the tested EPC schemes for the B1.2.

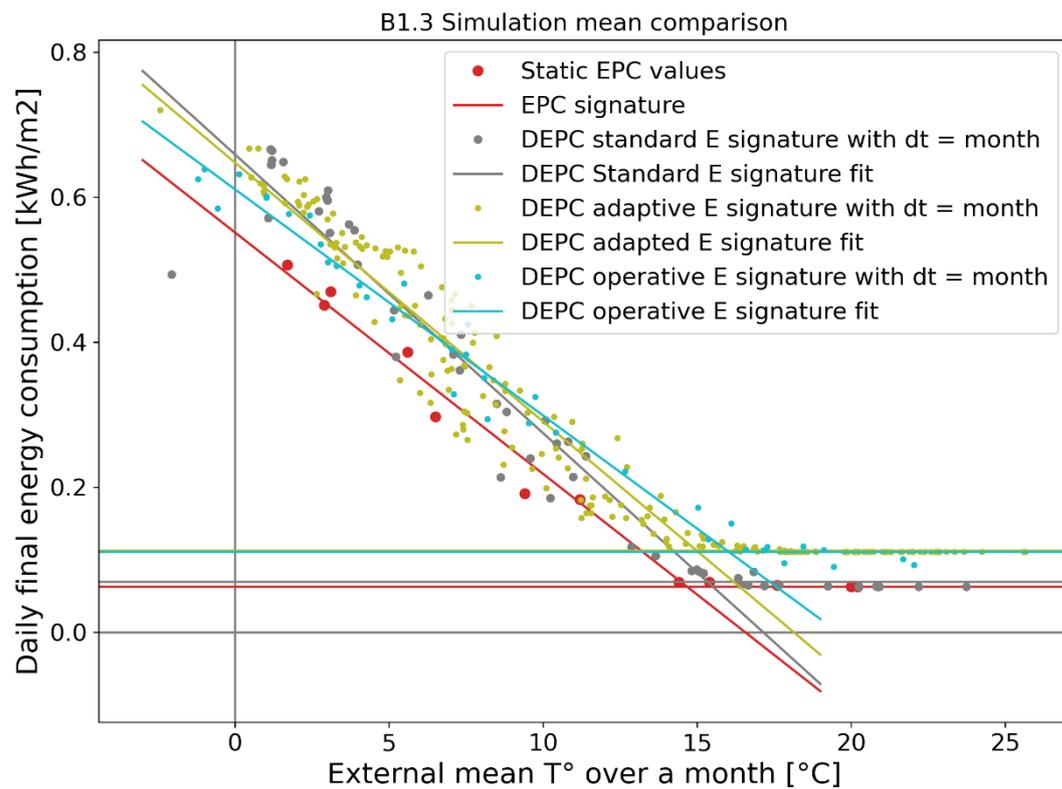
**Figure 49: Energy signature as a result of the tested EPC schemes for the B1.3.**

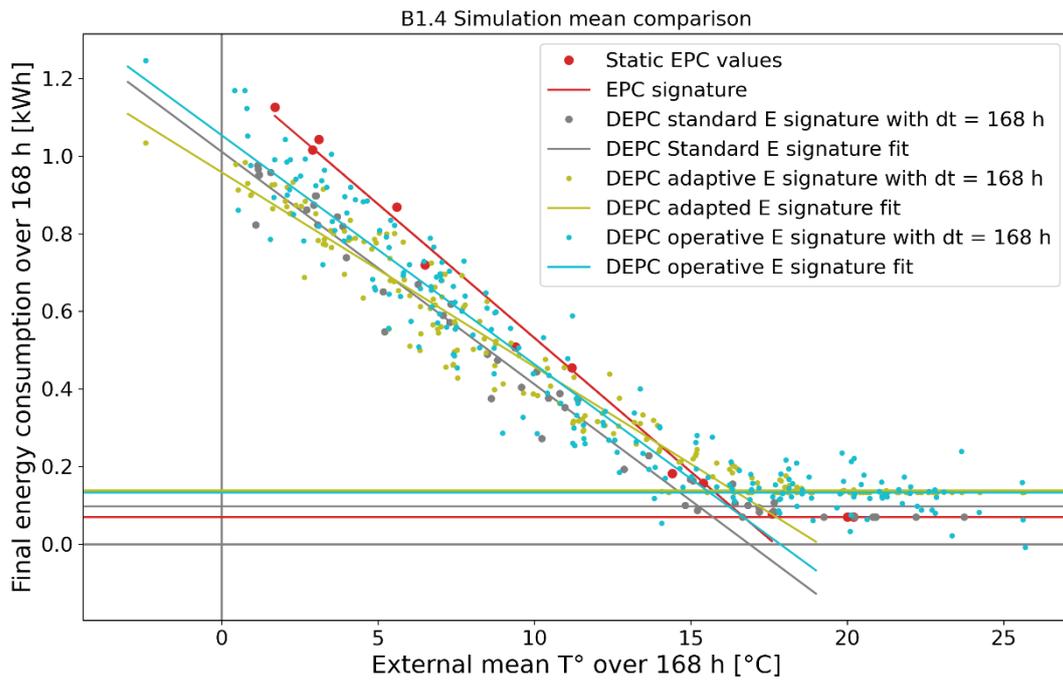
**Figure 50: Energy signature as a result of the tested EPC schemes for the B1.4.**

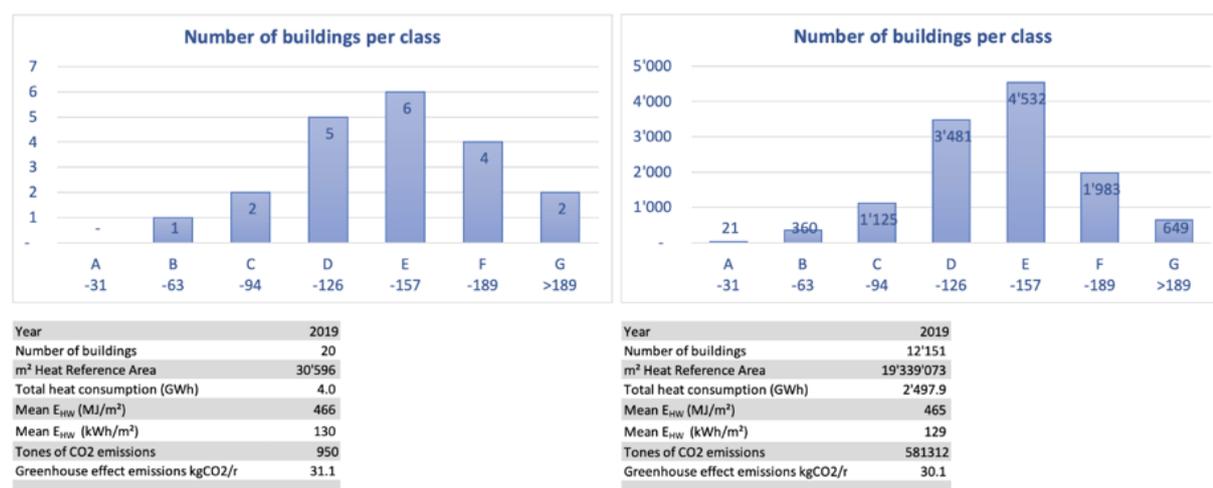
Figure 51: Energy profile of the E-DYCE sample (left) and the whole Canton building stock (right).

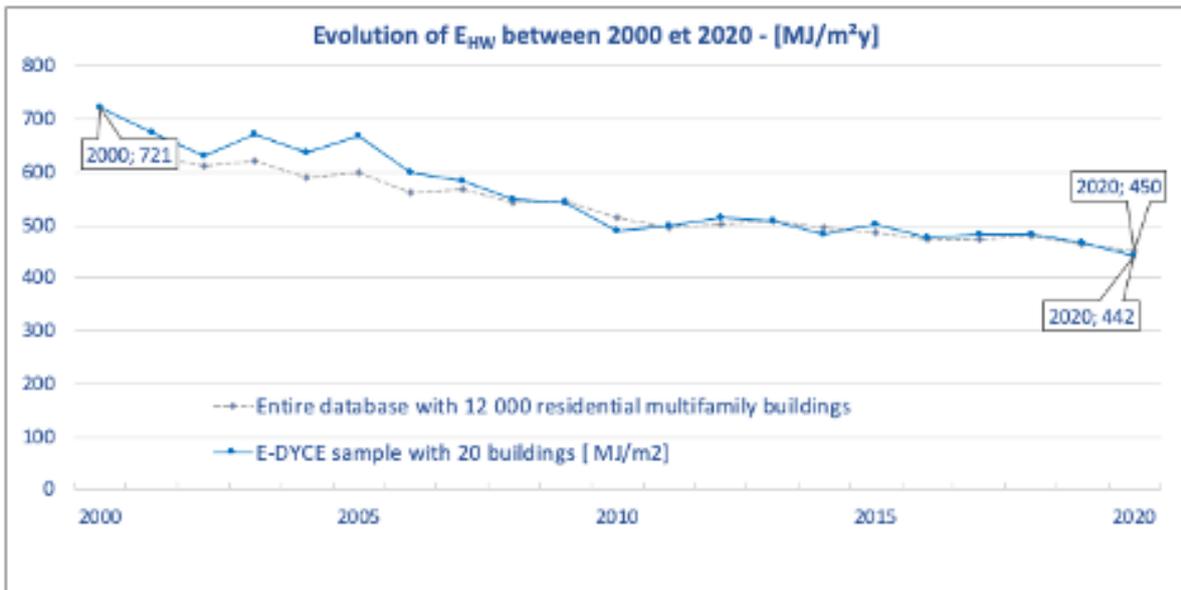
Figure 52: Evolution of the EHW of the E-DYCE sample and the entire Geneva building stock of residential buildings since 2000.

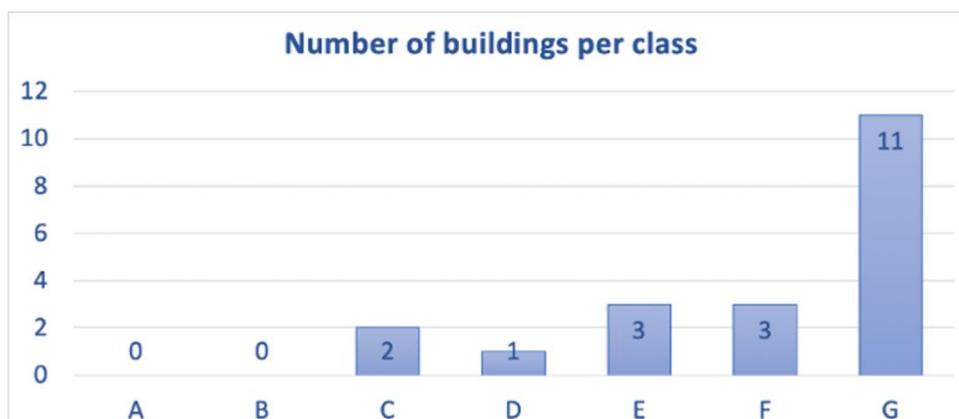
Figure 53: Envelope energy class according to Swiss EPC

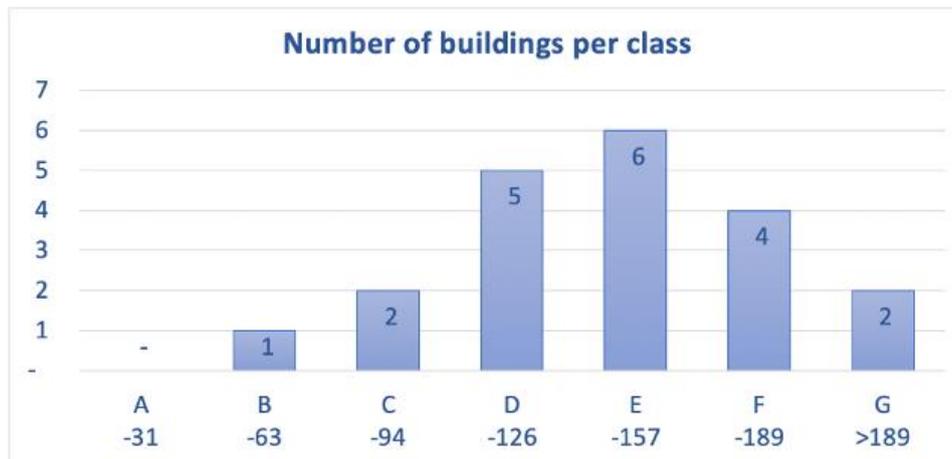
**Figure 54: Envelope energy class according to measured heat consumption**

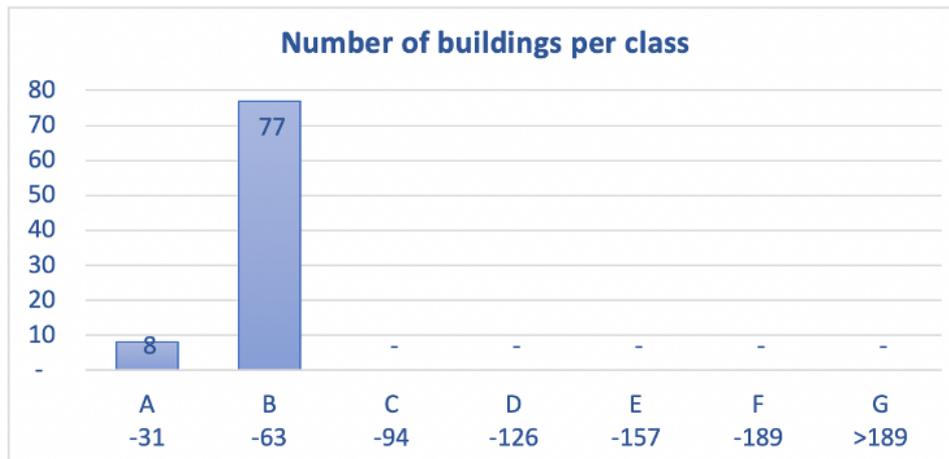
Figure 55: Expected  $E_{HW}$  of labelled high energy performance renovations

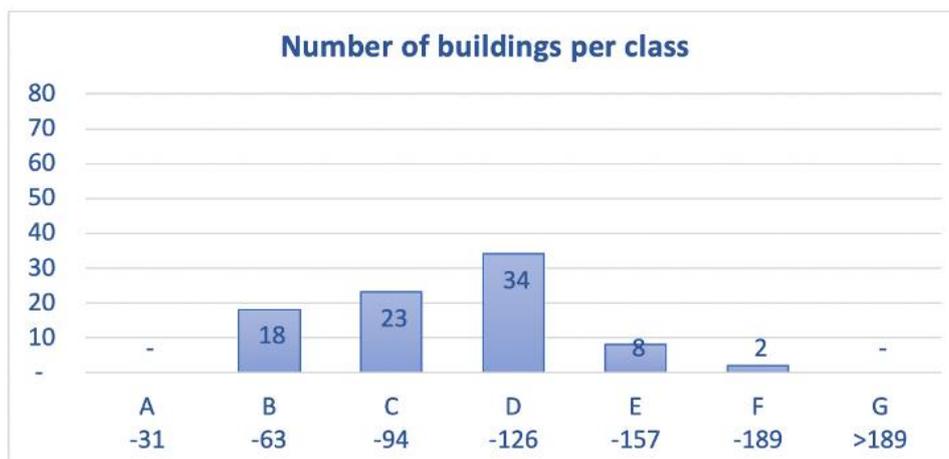
Figure 56: Measured  $E_{HW}$  in 2020

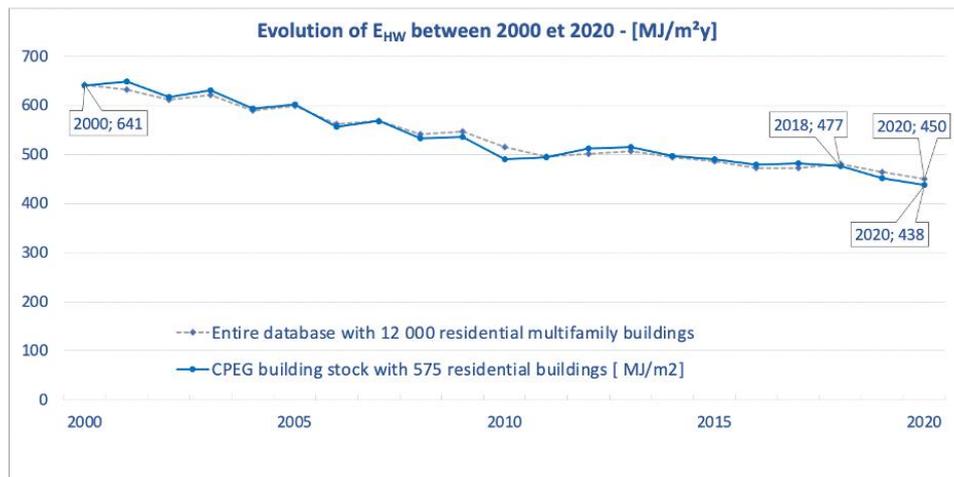
Figure 57: Evolution of the  $E_{HW}$  of the entire CPEG building stock and entire Canton building stock of residential buildings since 2000.

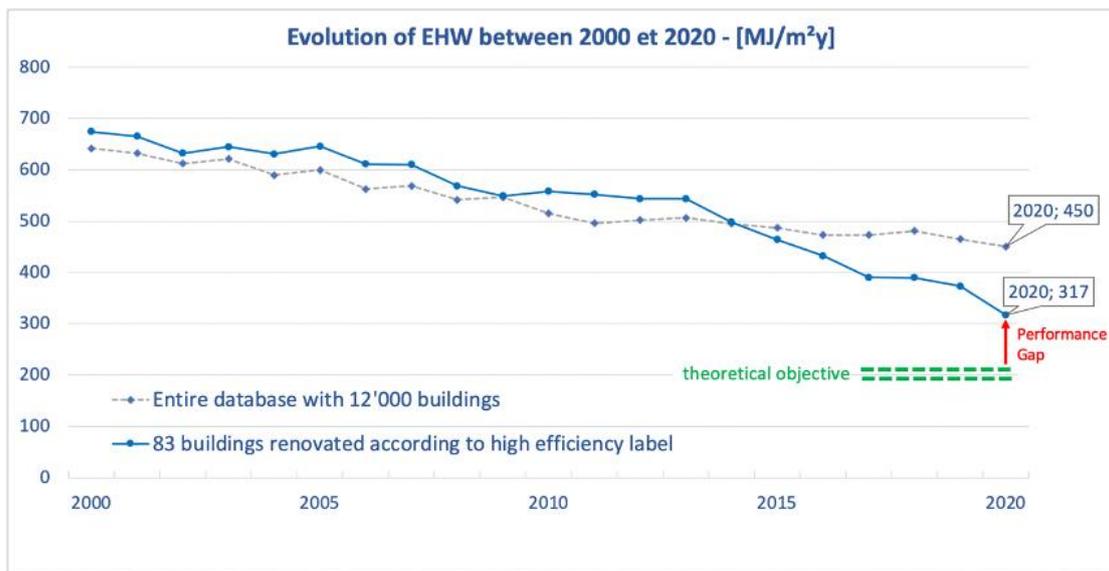
Figure 58: Example of policy failure revealed by historical real energy consumption analysis

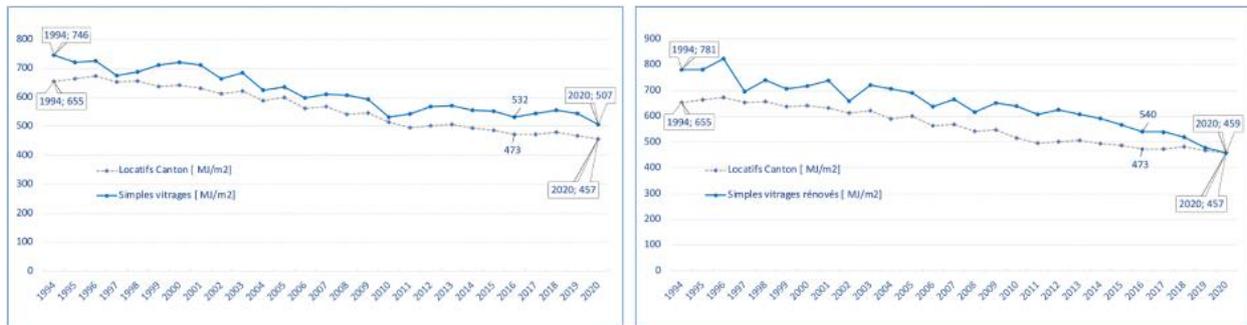
**Figure 59: The left graph shows  $E_{HW}$  of a group of 26 buildings with non-renovated single glazing windows. The right graph shows  $E_{HW}$  of 37 buildings with renovated single glazing windows.**

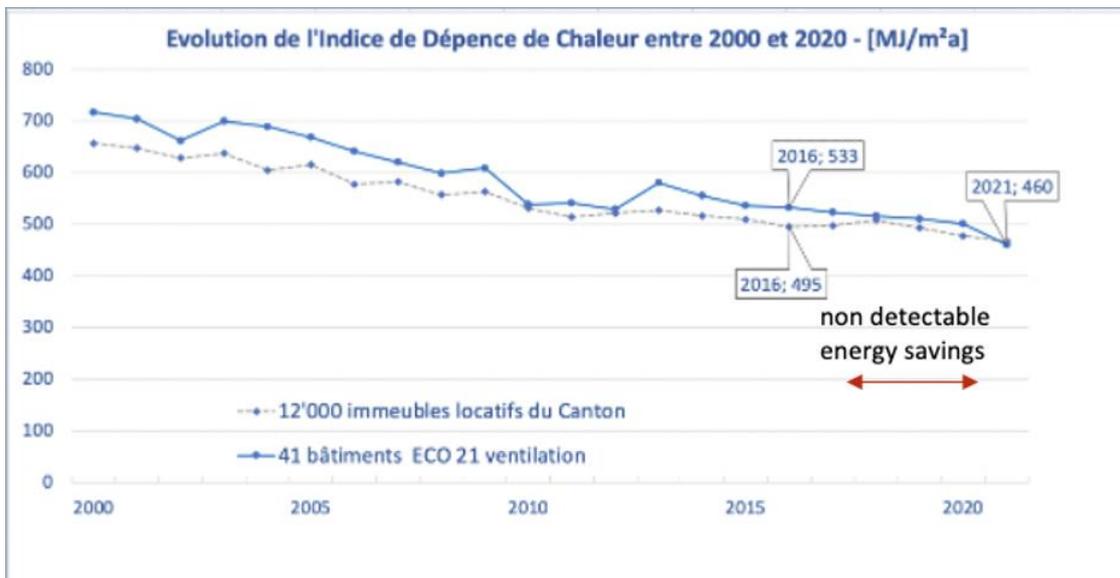
**Figure 60: A set of 41 buildings with renovated ventilation systems between 2017 and 2019 show a real energy reduction in 2021, 3 years after the program monitoring.**
